Energy Efficient Building Envelopes in Schools

Meghan McDermott, BECxP, CxA+BE

High Performance Building Solutions

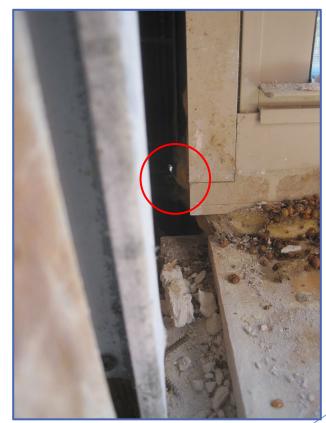
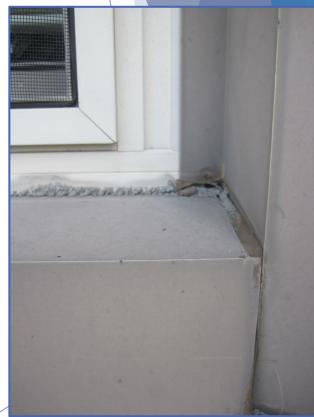
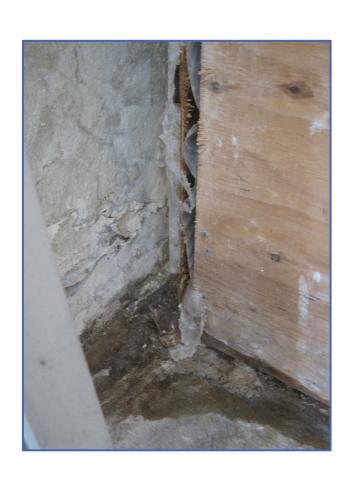
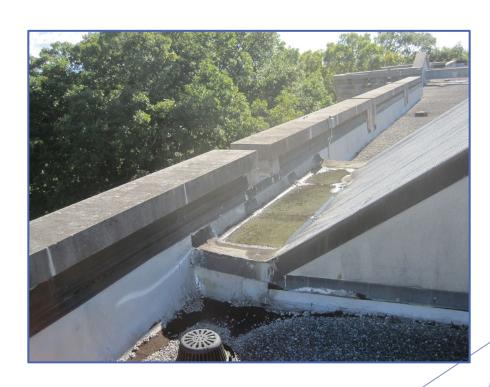
- ► Inspection Found:
 - ▶ Bulk Water Intrusion
 - Moisture Vapor Intrusion
 - ► Excessive Air Infiltration
 - ► Structural Issues

- Repairs:
 - ► Added Air Barrier & Thermal Barrier
 - ► Replaced Windows
- ► Challenges:
 - ► Historic Building
 - ▶ Subcontractors
- ► Completed 2016

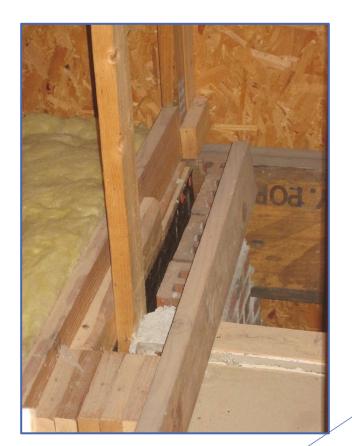
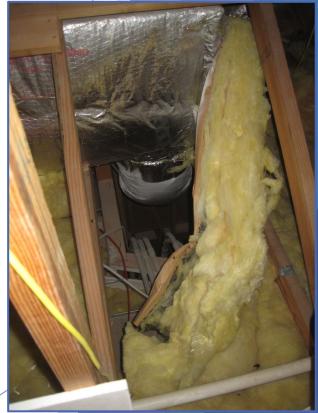
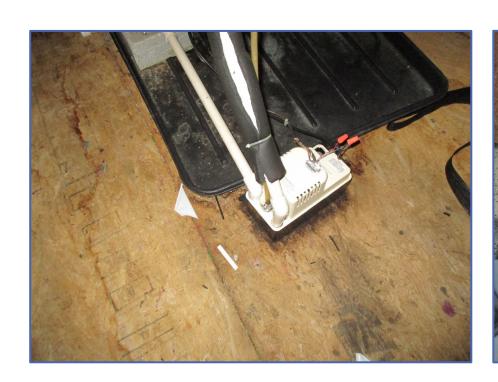
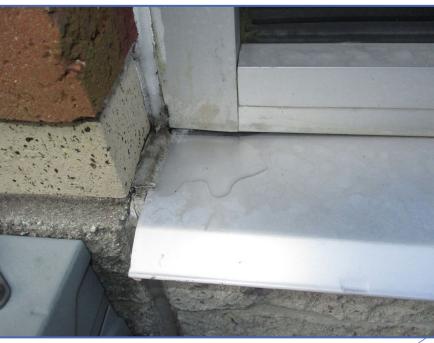
- ► Inspection Found:
 - ► Incomplete Air Barrier
 - Vented Attic Directly Connected to Conditioned Space
 - Back Drafting Water Heaters
 - ► HVAC Service Issues

- ► Repairs:
 - ► Attic Air Sealing
 - ▶ Soffit Air Sealing
 - ▶ Roof Replacement
- ► Challenges:
 - ▶ Hurricane Florence
 - ▶ Nights & Weekends

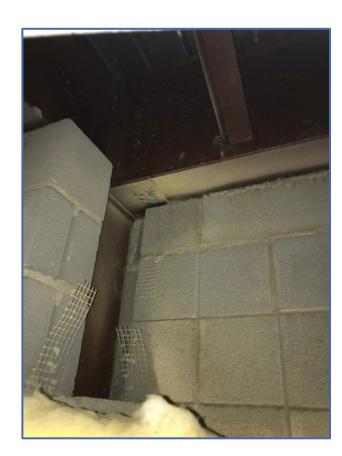
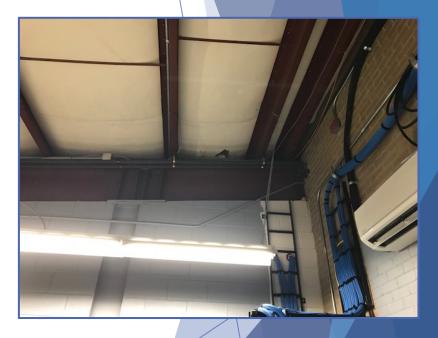
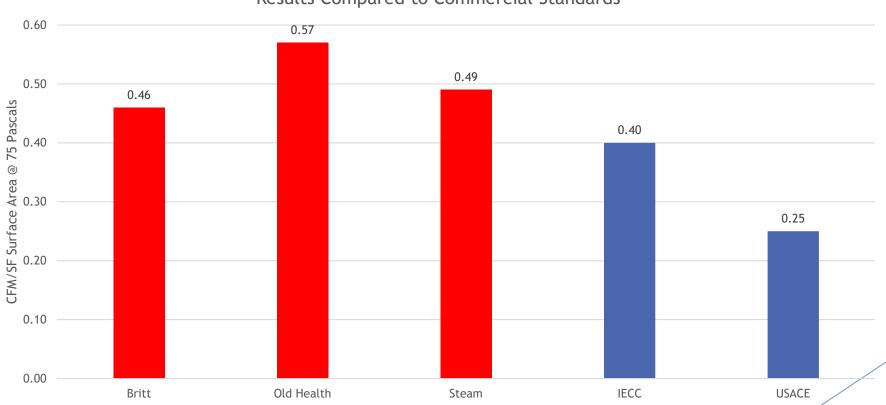
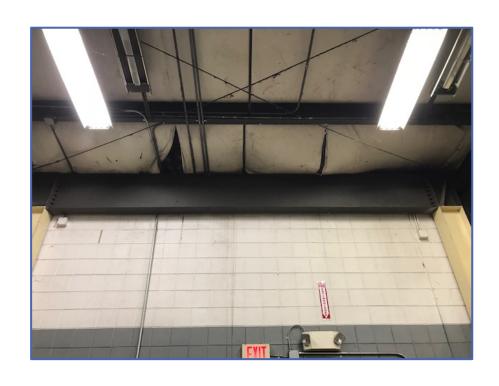
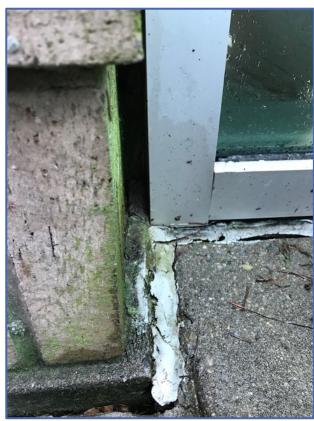
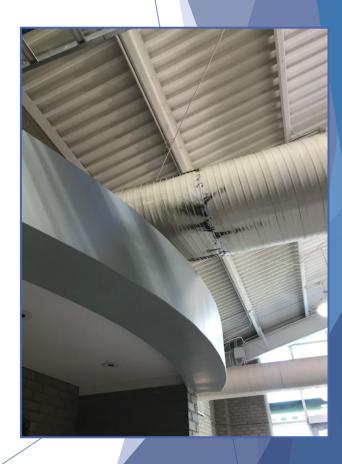
- ► Inspection Found:
 - ➤ Only 5 out of the 9 buildings <10 year Payback</p>
 - Other buildings required repair but did not meet the payback requirements
 - ► Incomplete Air Barrier
 - ▶ Bulk Water Intrusion
 - ▶ Duct Leakage
