2017 Retrofit Magazine Conference

Presentation on: **Energy Retrofit Case Studies**

Presenter: Brian Stroik

Manager - Building Envelope Solutions Team

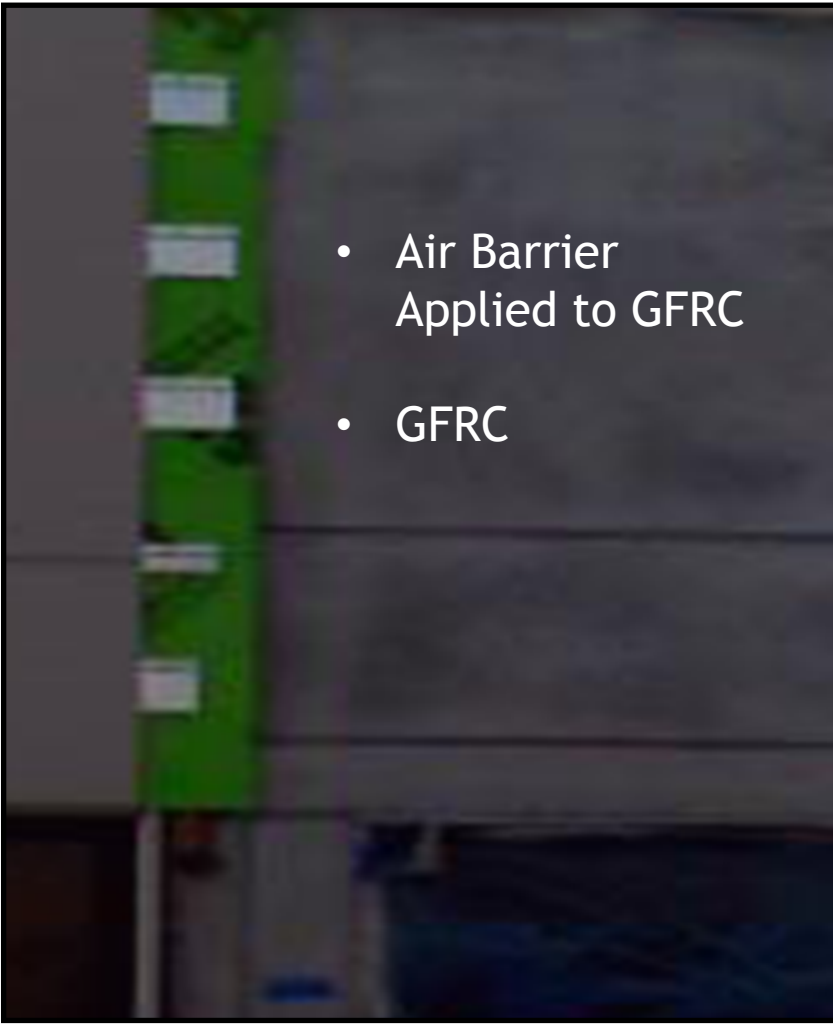
Air Barrier – **No Insulation**

- Air Barrier Applied to GFRC
 - GFRC

Air Barrier – No Insulation

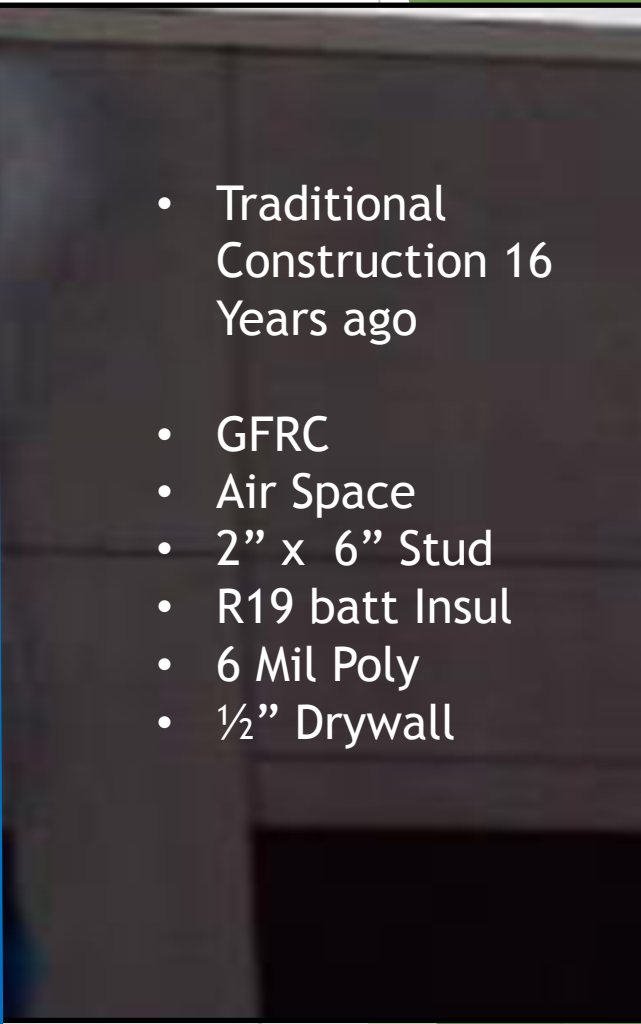
- Traditional Construction 16 Years ago
 - GFRC
 - Air Space
 - 2" x 6" Stud
 - R19 batt Insul
 - 6 Mil Poly
 - ½" Drywall

NO Air Barrier & Insulation

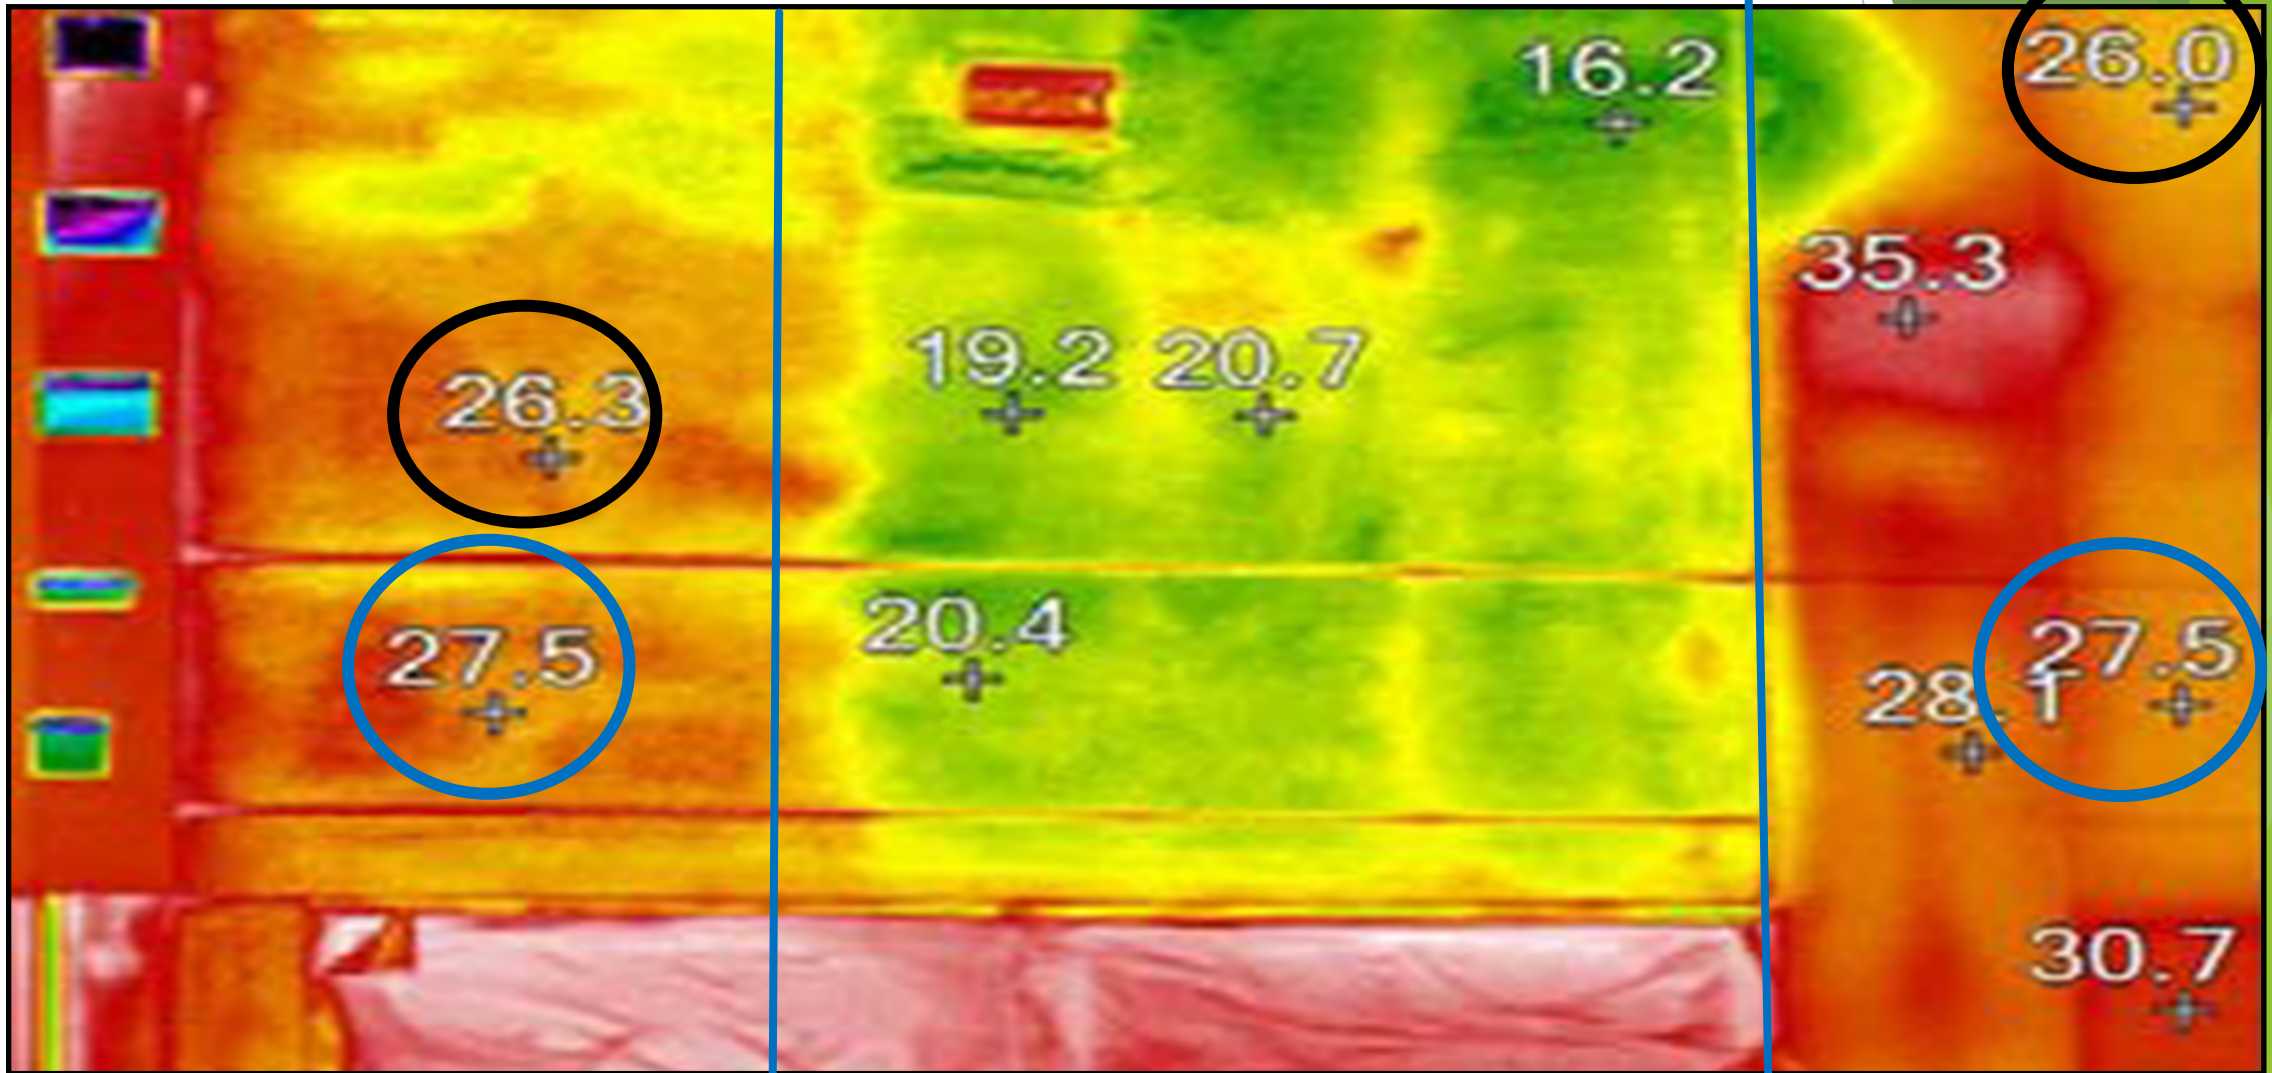
Air Barrier w Insulation

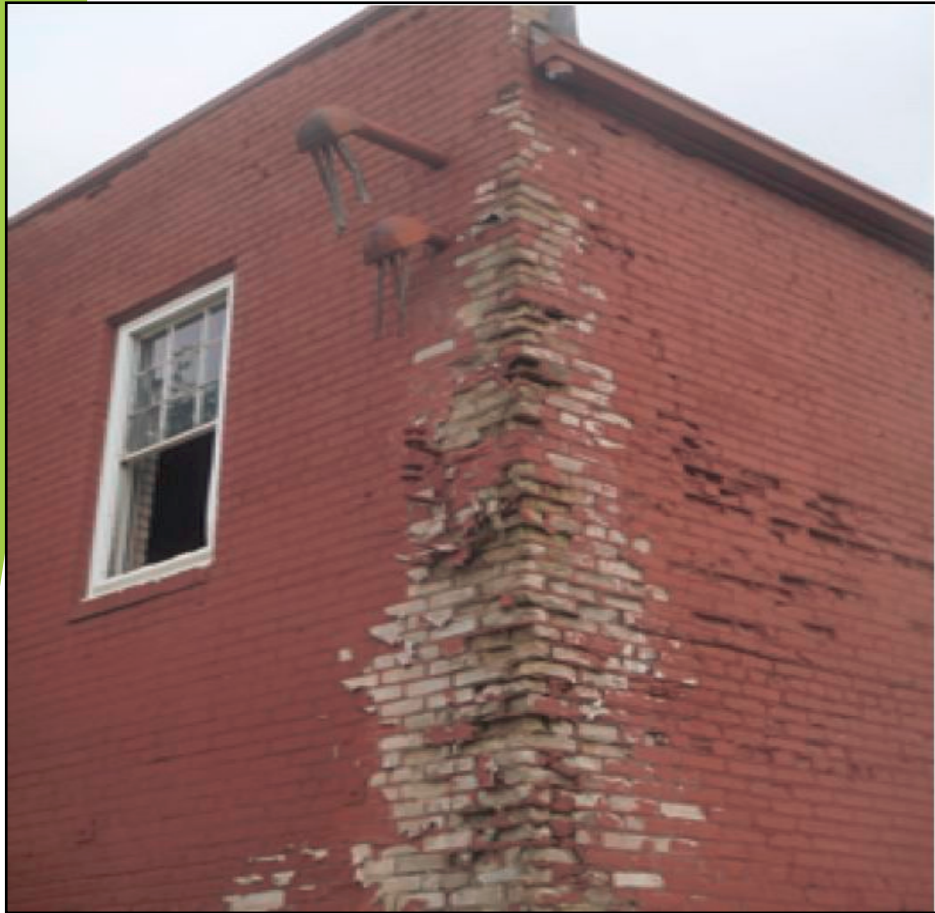
Photo by: Construction Specifier Institute

Make Sure Brick Can Handle Different Moisture / Freeze Thaw Cycles

- ASTM C67 – 14
Standard Test Methods for
Sampling and Testing Brick
and Structural Clay Tile

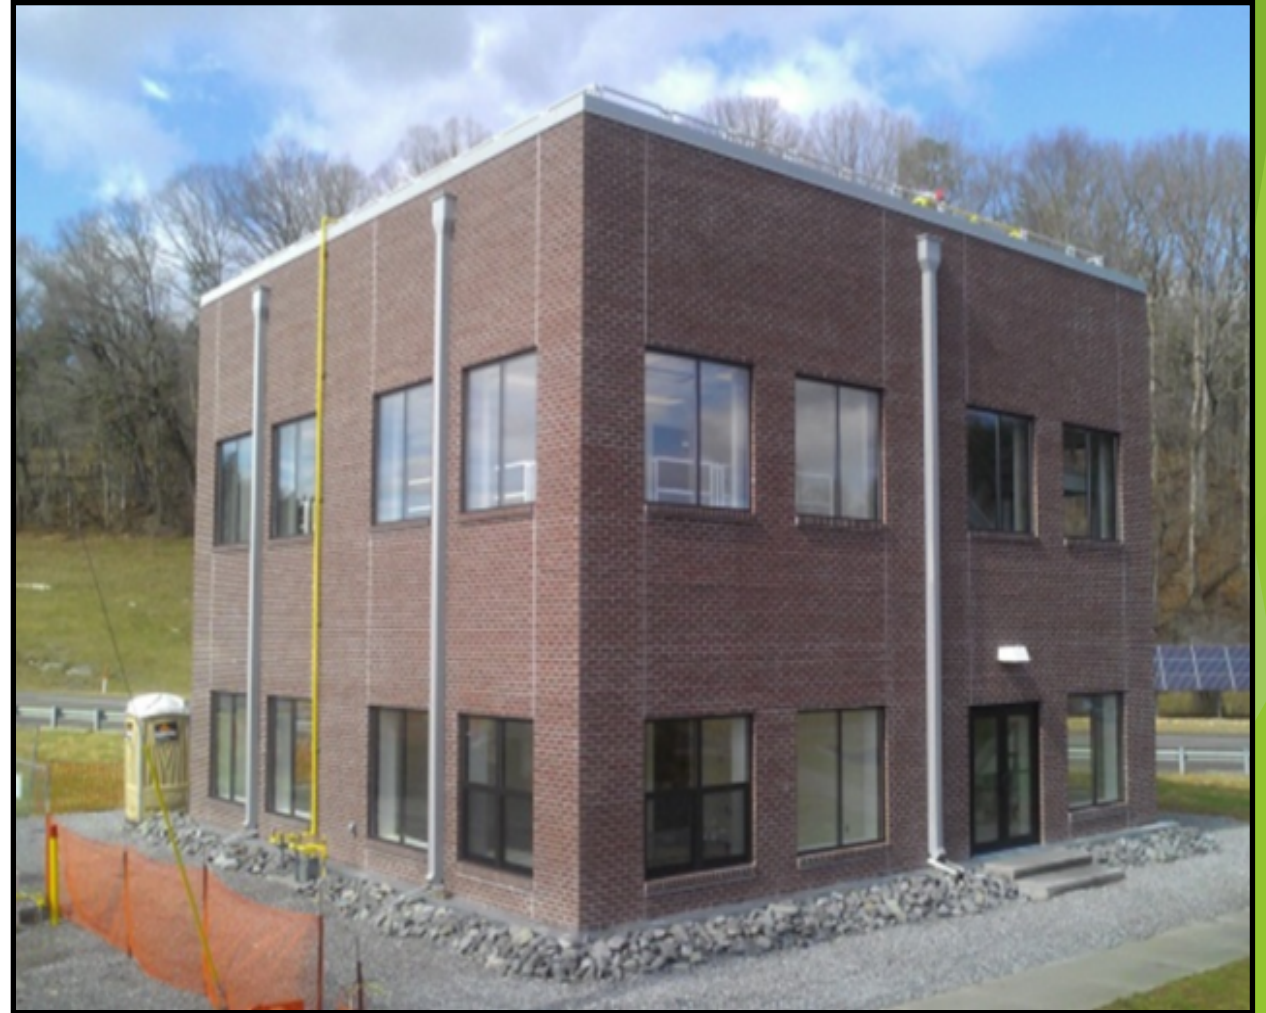
ORNL - Test Hut

Data Collection from September 2015
and November 2015 Findings:

- Spray Foam Wall maintained more constant interior temperature as temperatures dropped into Winter Months
- Spray Foam Wall higher improvement in insulating properties in cold conditions
- Moisture Content for BOTH Walls were within the 40% - 70% range which was below the Critical Moisture Content Level (80%) - ASHRAE 160

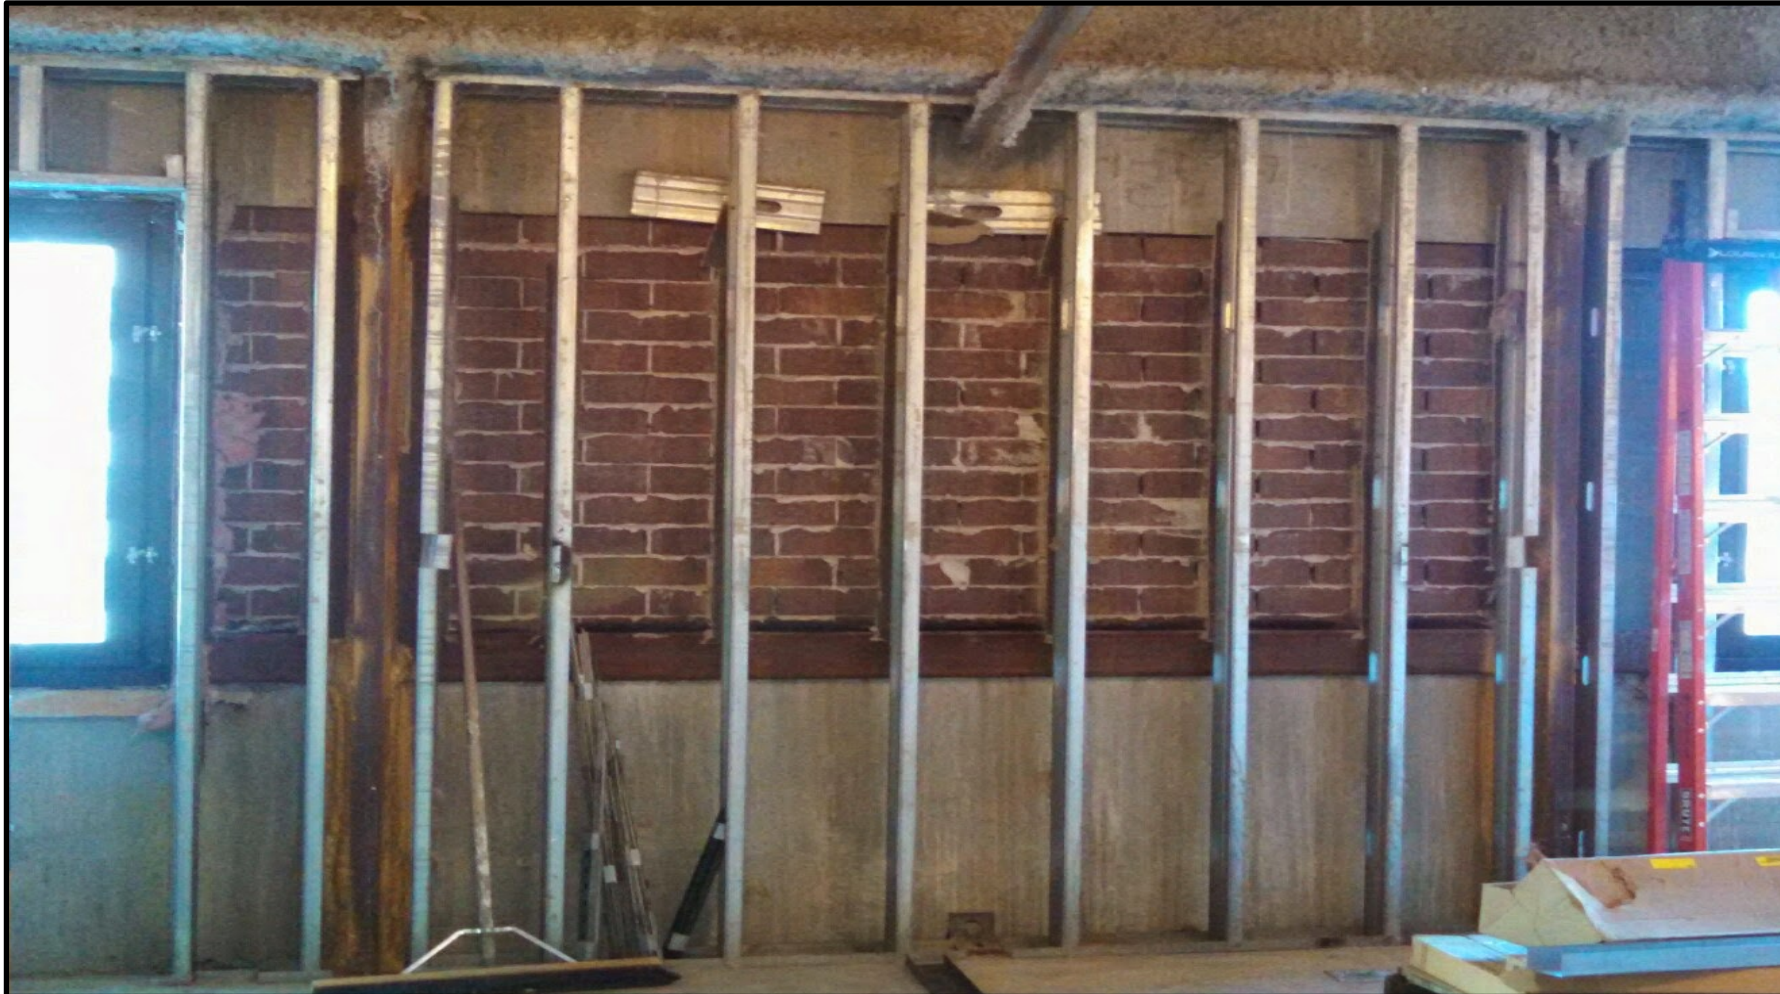
- Project B - Milwaukee WI
 - New Wall
 - Existing Brick & Precast / New Windows / Rigid Foam & SPF / Existing Studs / New Drywall

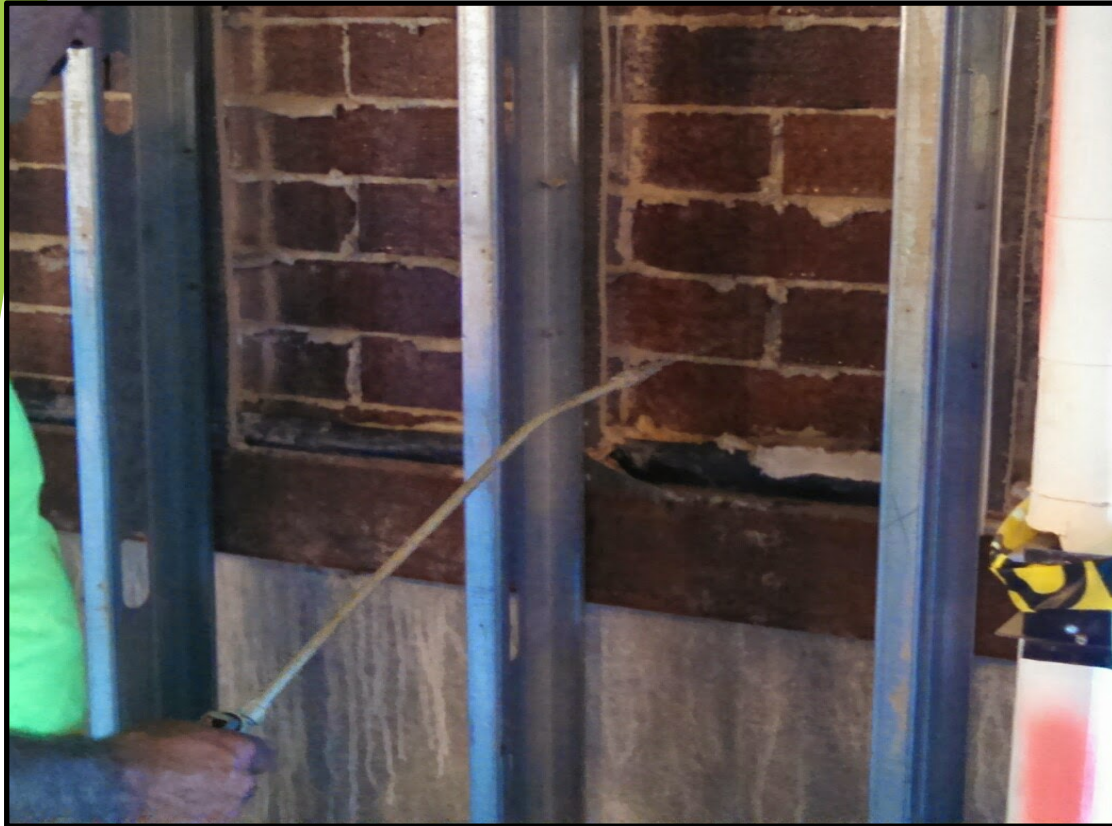
- Project B - Milwaukee WI
 - New Wall
 - Existing Brick & Precast / New Windows / Rigid Foam & SPF / Existing Studs / New Drywall

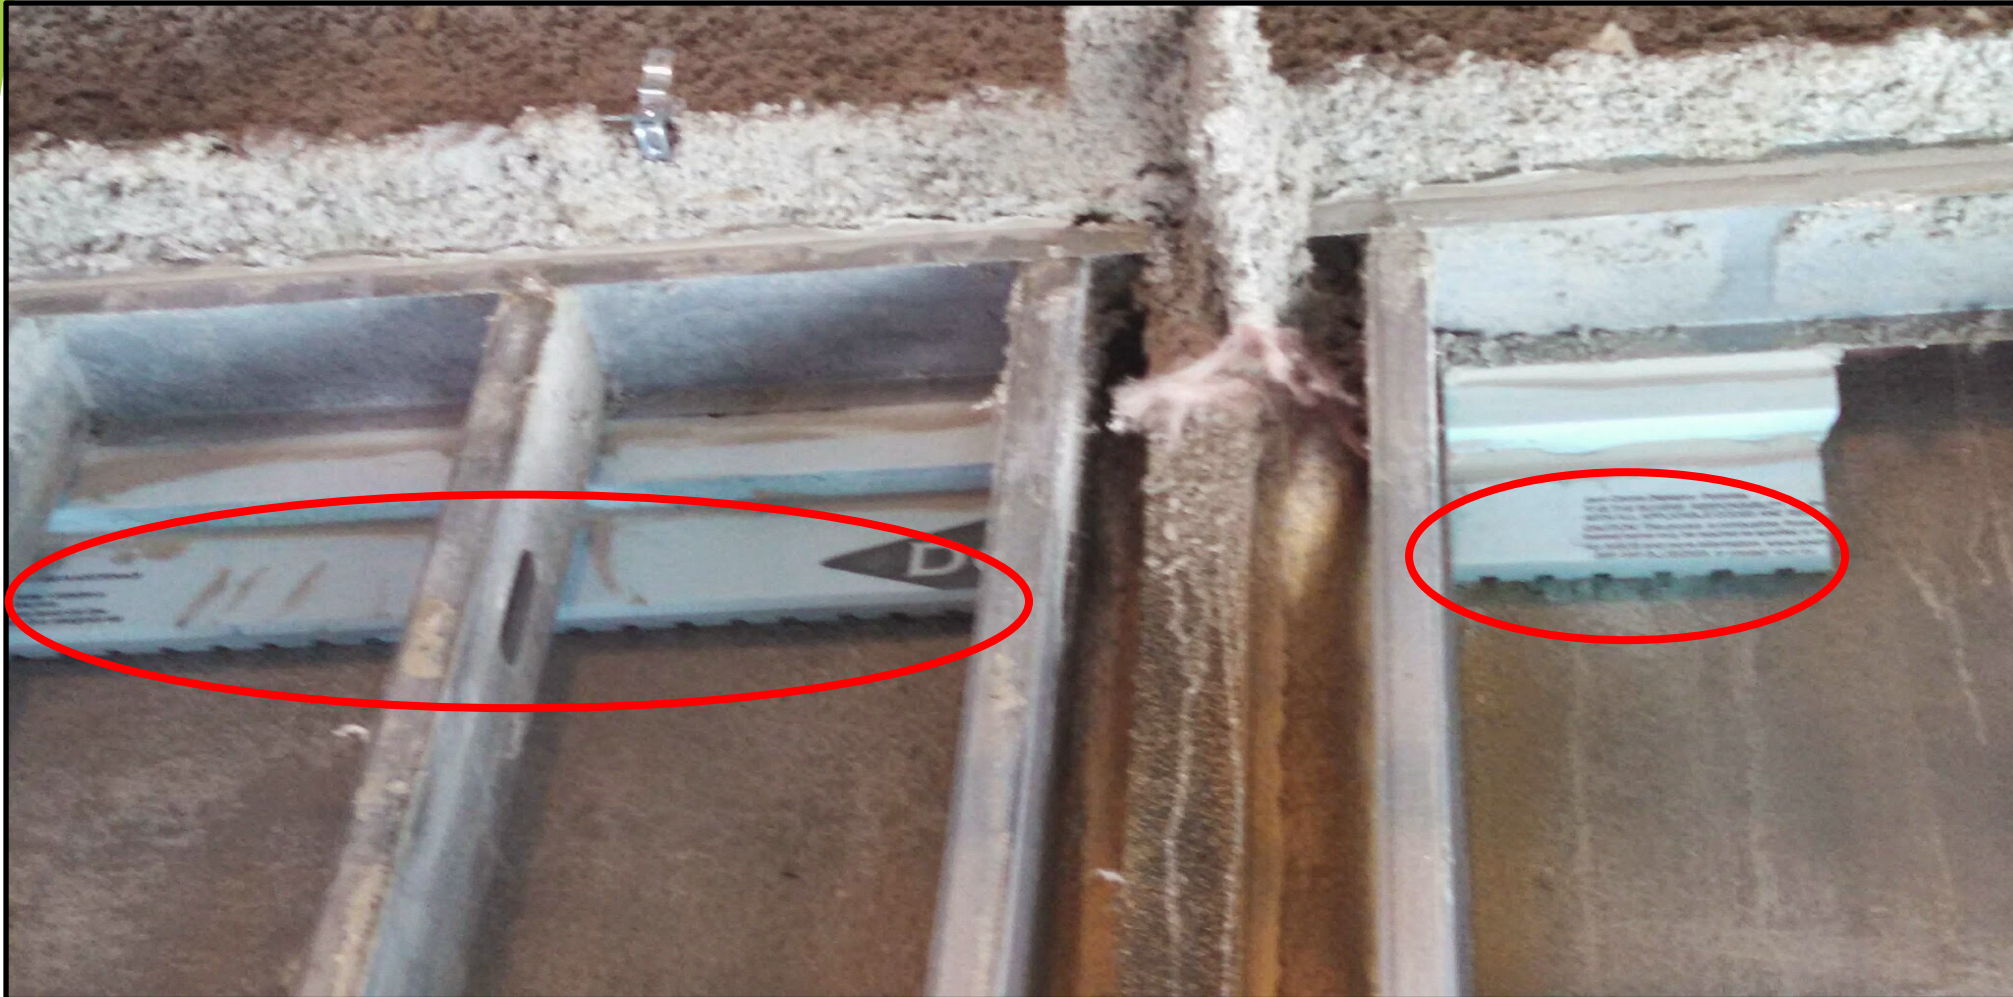
- Project B - Milwaukee WI
 - New Wall
 - Existing Brick & Precast / New Windows / Rigid Foam & SPF / Existing Studs / New Drywall

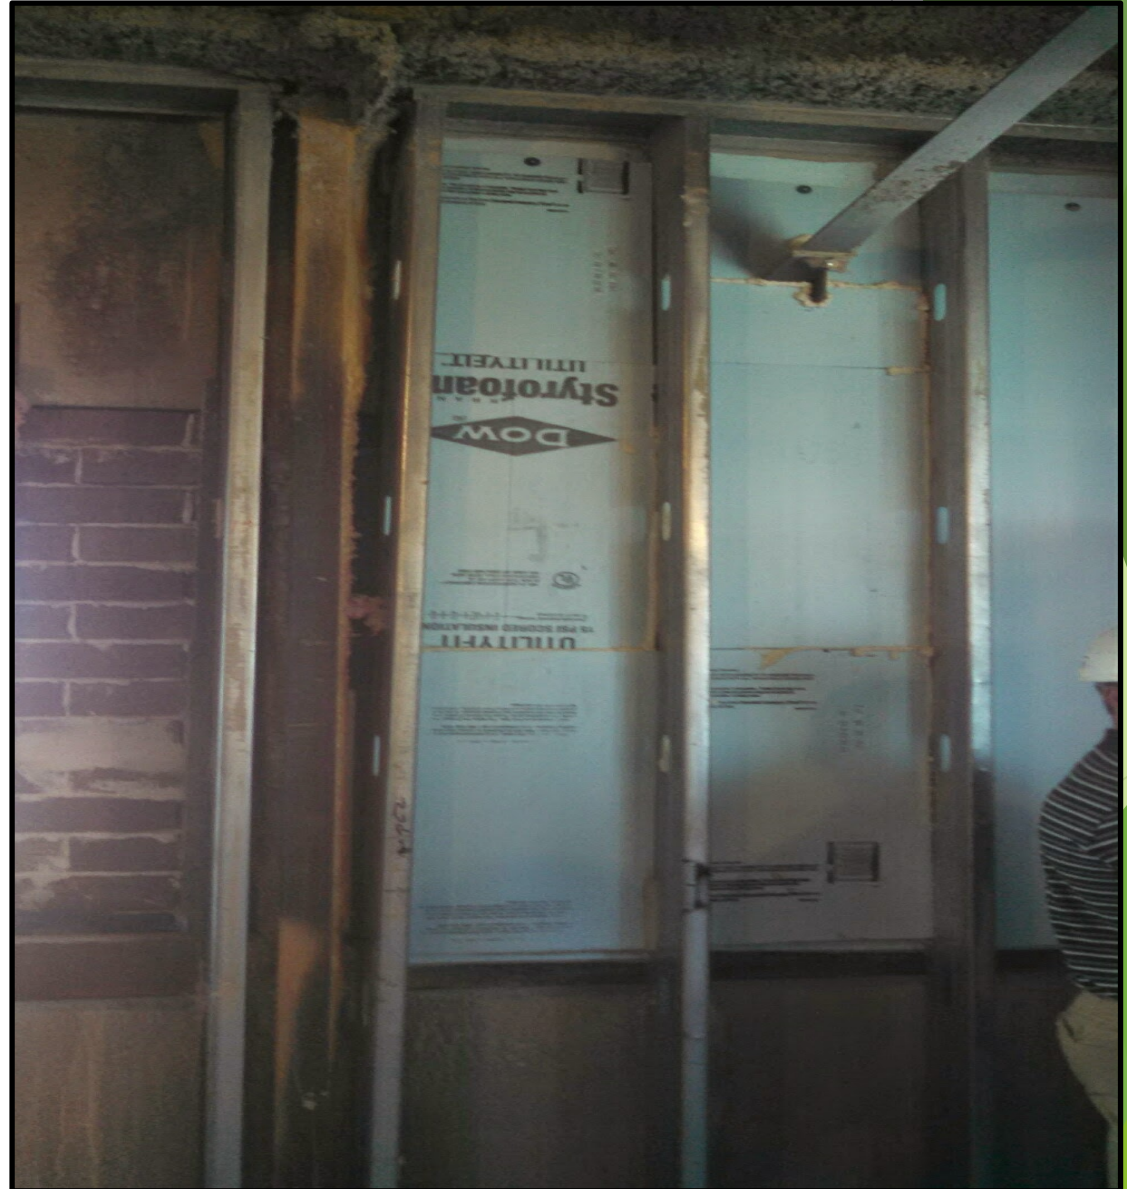
- Project B - Milwaukee WI
 - New Wall
 - Existing Brick & Precast /
New Windows / Rigid Foam
& SPF / Existing Studs /
New Drywall

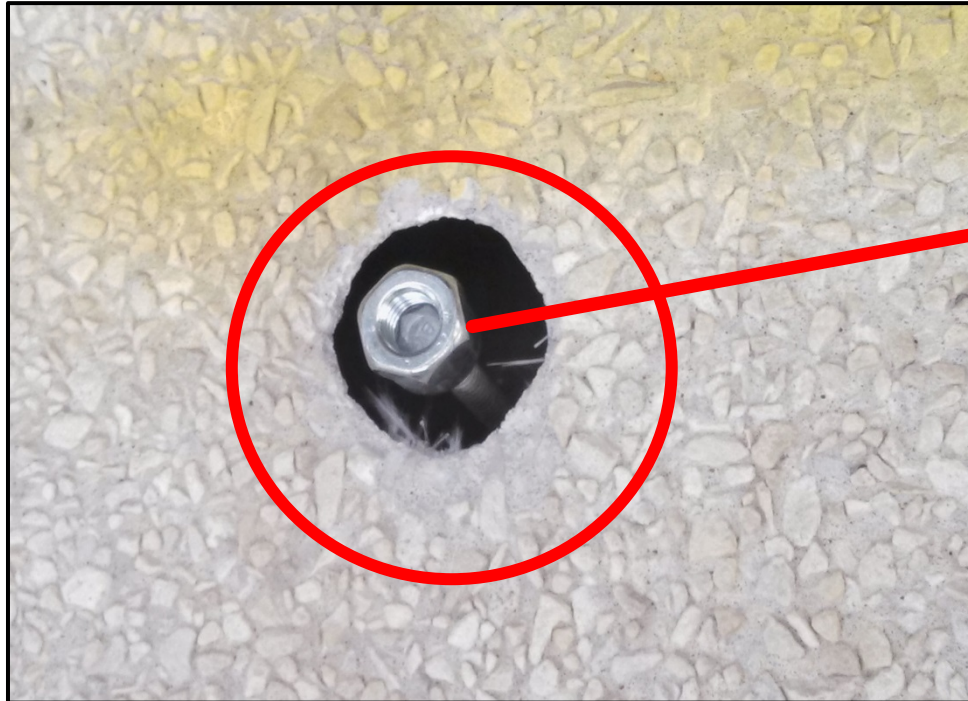
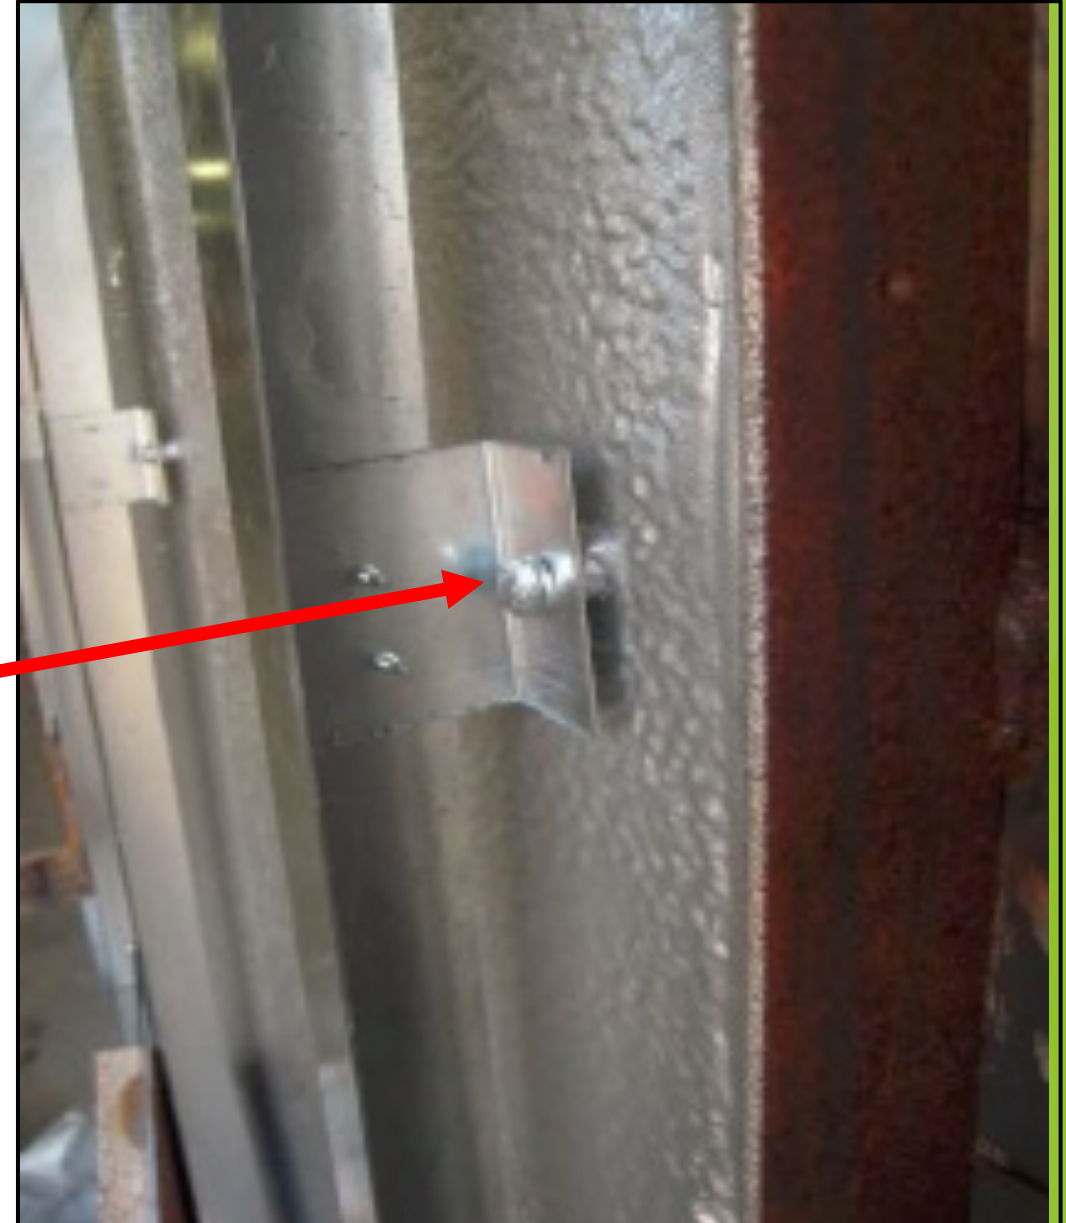
- Project C - Hospital Climate Zone 5
 - New Exterior Wall
 - Existing GFRC Panel / Clip and Rail to Structure / Air Barrier / Windows / SPF / Exterior Sheathing / Metal Panels

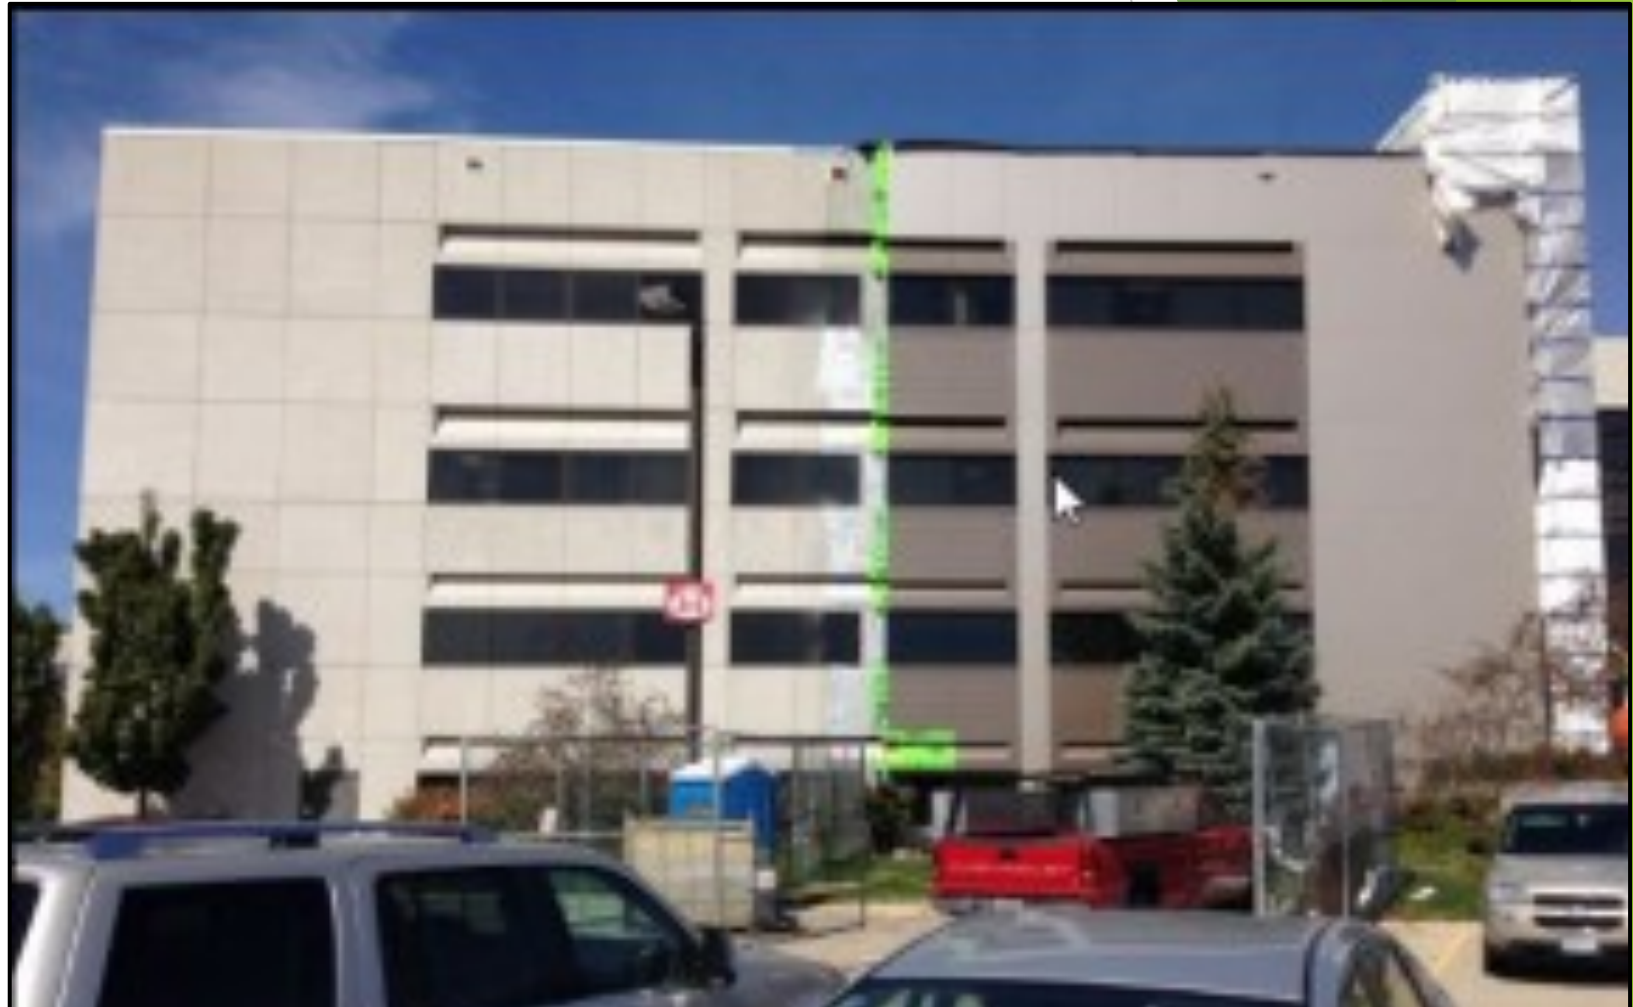
- Project C - Hospital Climate Zone 5
 - New Exterior Wall
 - Existing GFRC Panel / Clip and Rail to Structure / Air Barrier / Windows / SPF / Exterior Sheathing / Metal Panels

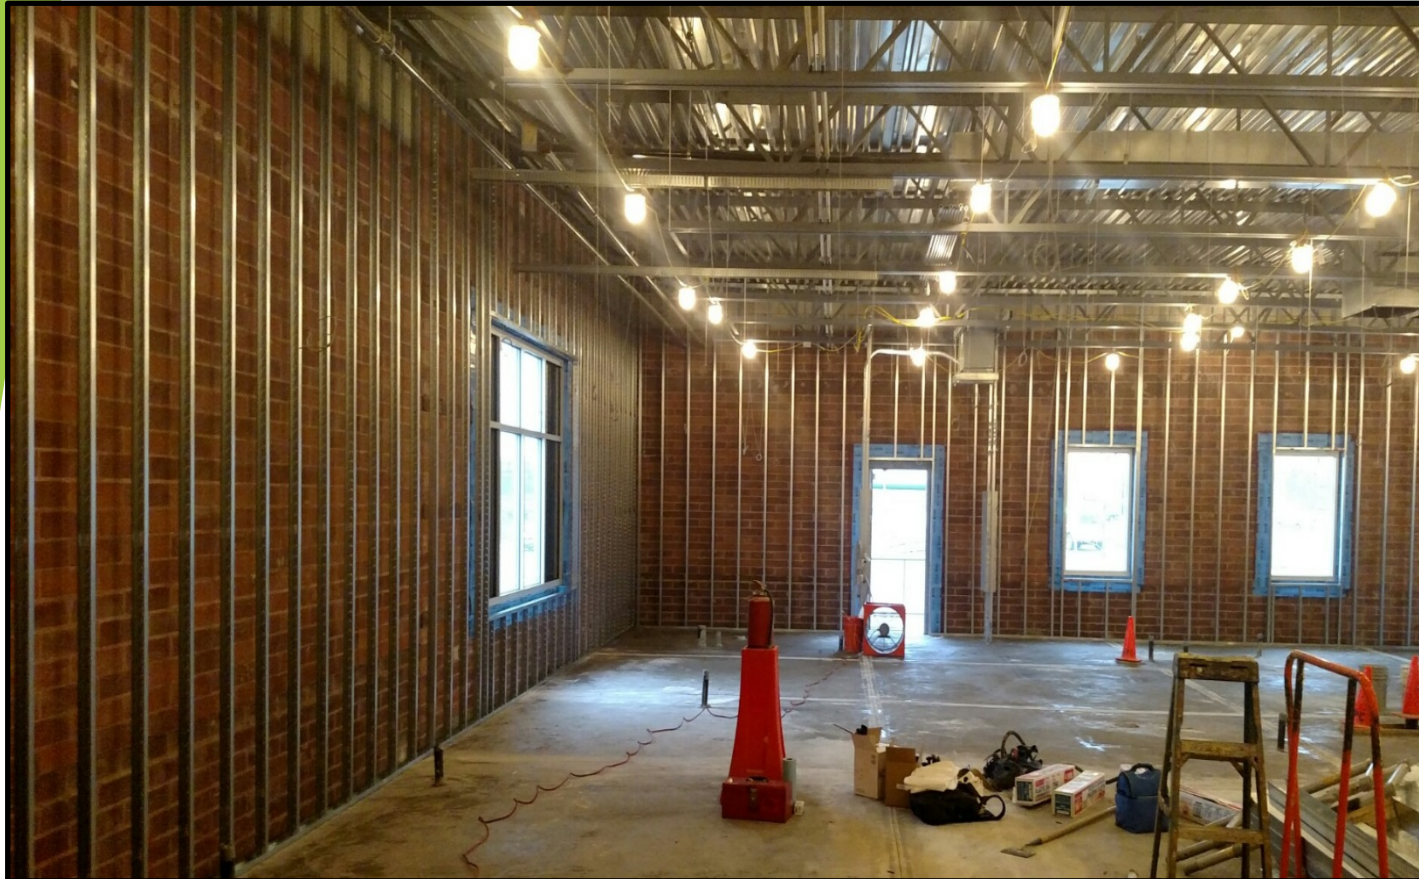
Project D - Chicago IL

- New Wall
 - Brick Barrier Wall (Interlocking courses) / SPF
 - / New Studs / Drywall

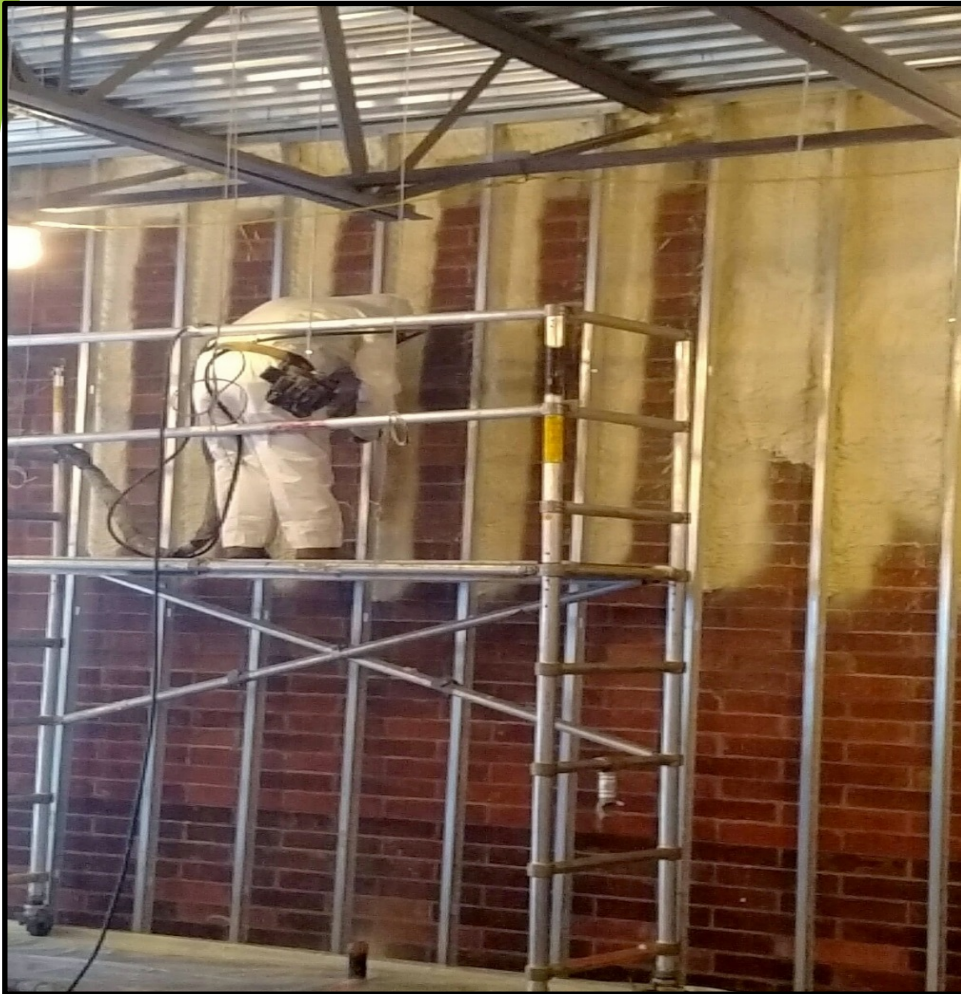
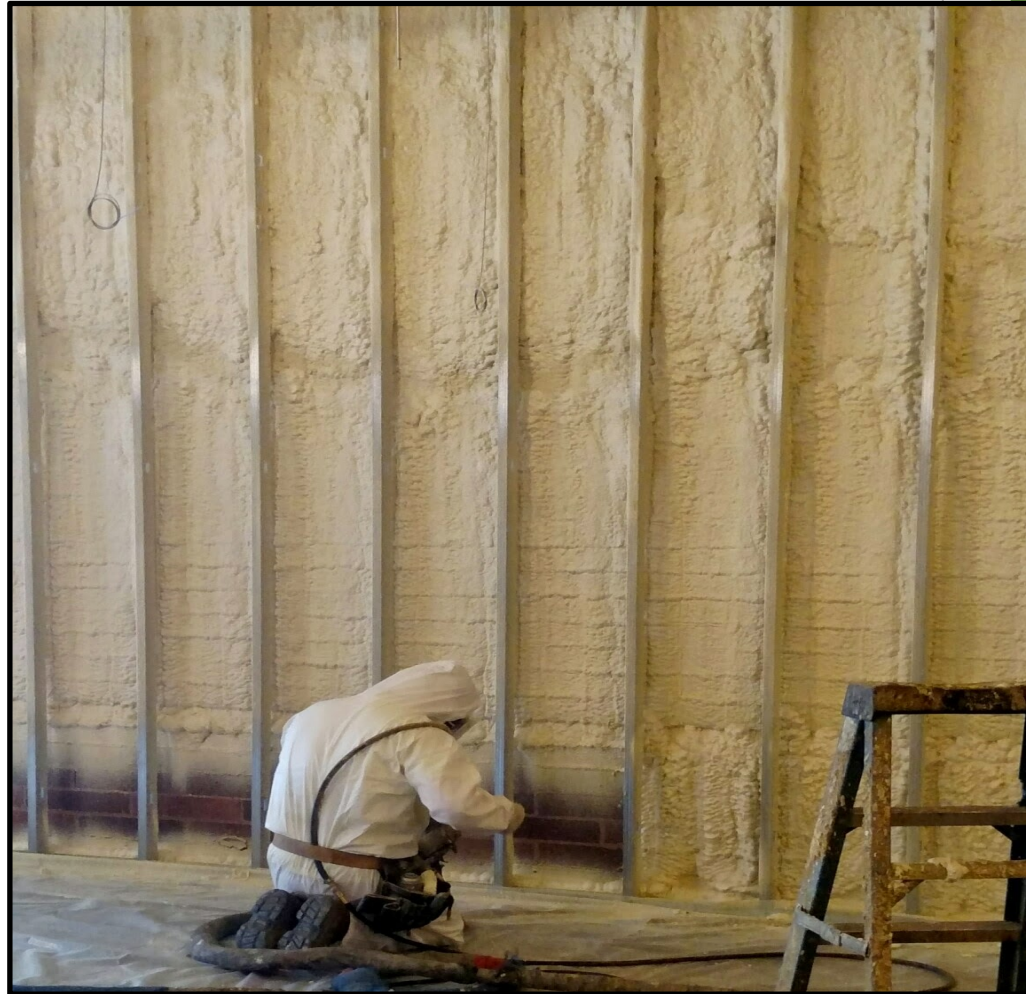
Project D - Chicago IL

- New Wall
 - Brick Barrier Wall (Interlocking courses) / SPF / New Studs / Drywall

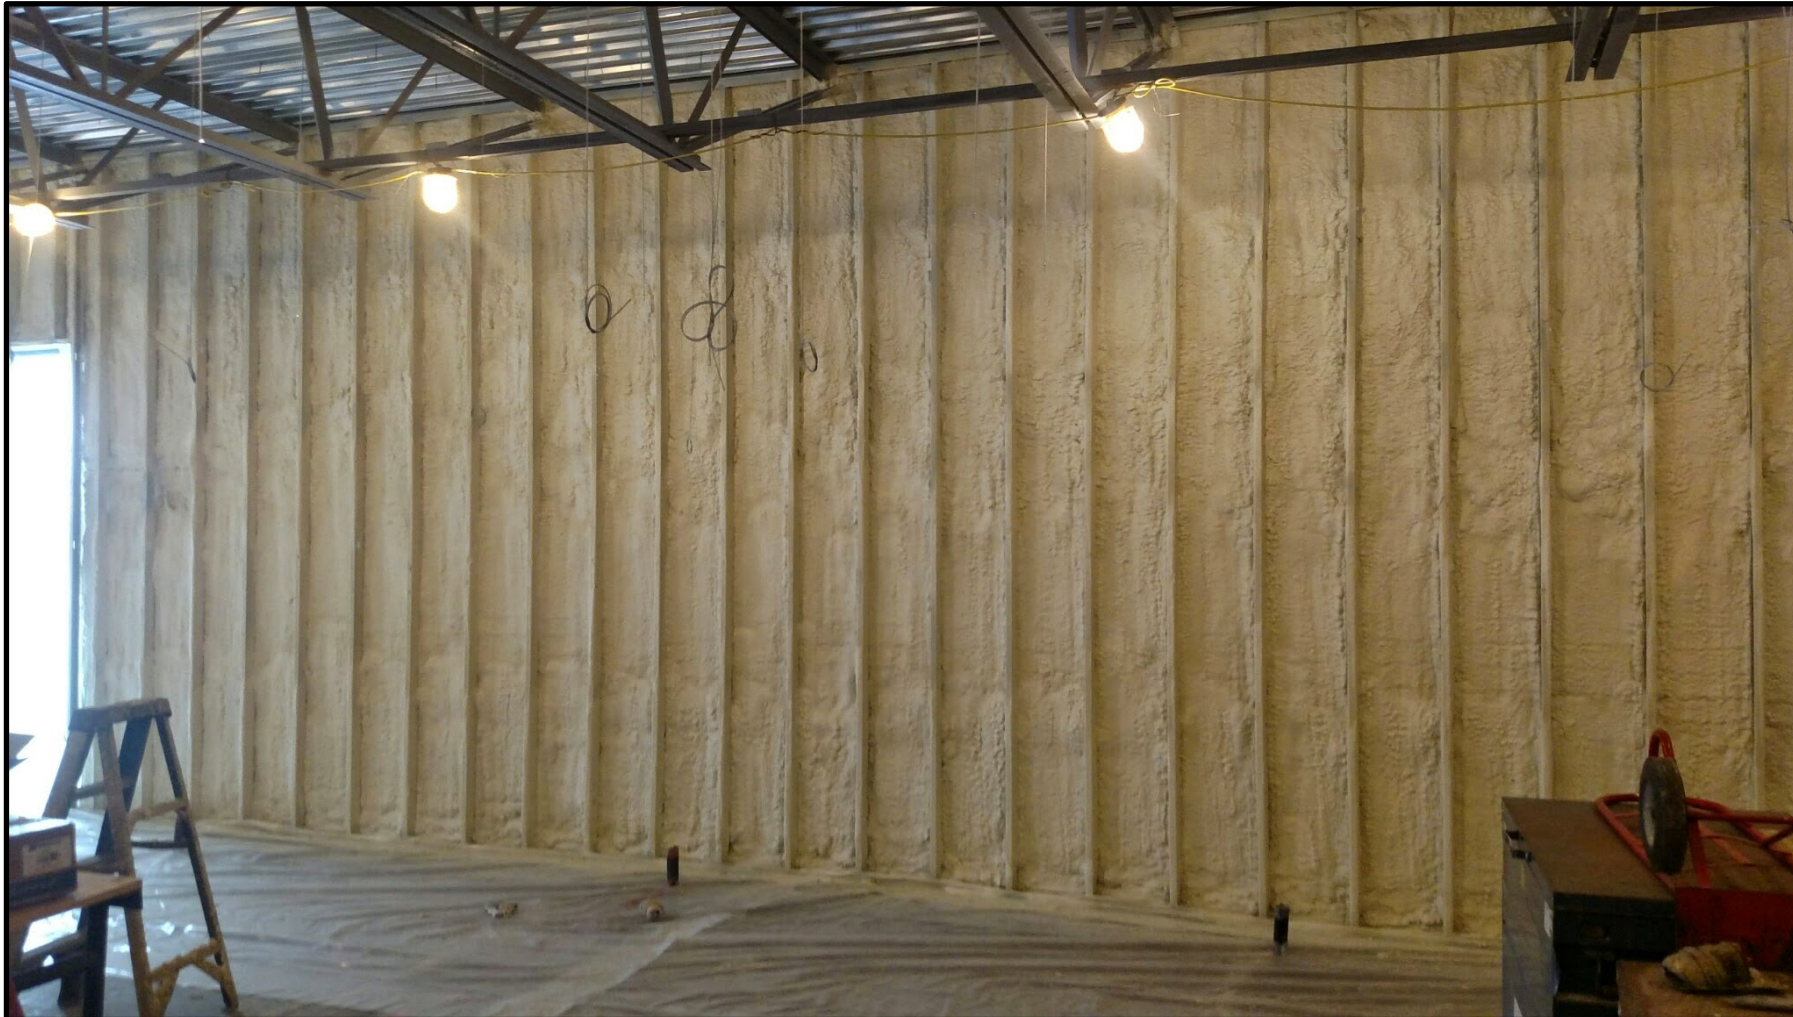
Project D - Chicago IL

- New Wall
 - Brick Barrier Wall (Interlocking courses) / SPF / New Studs / Drywall

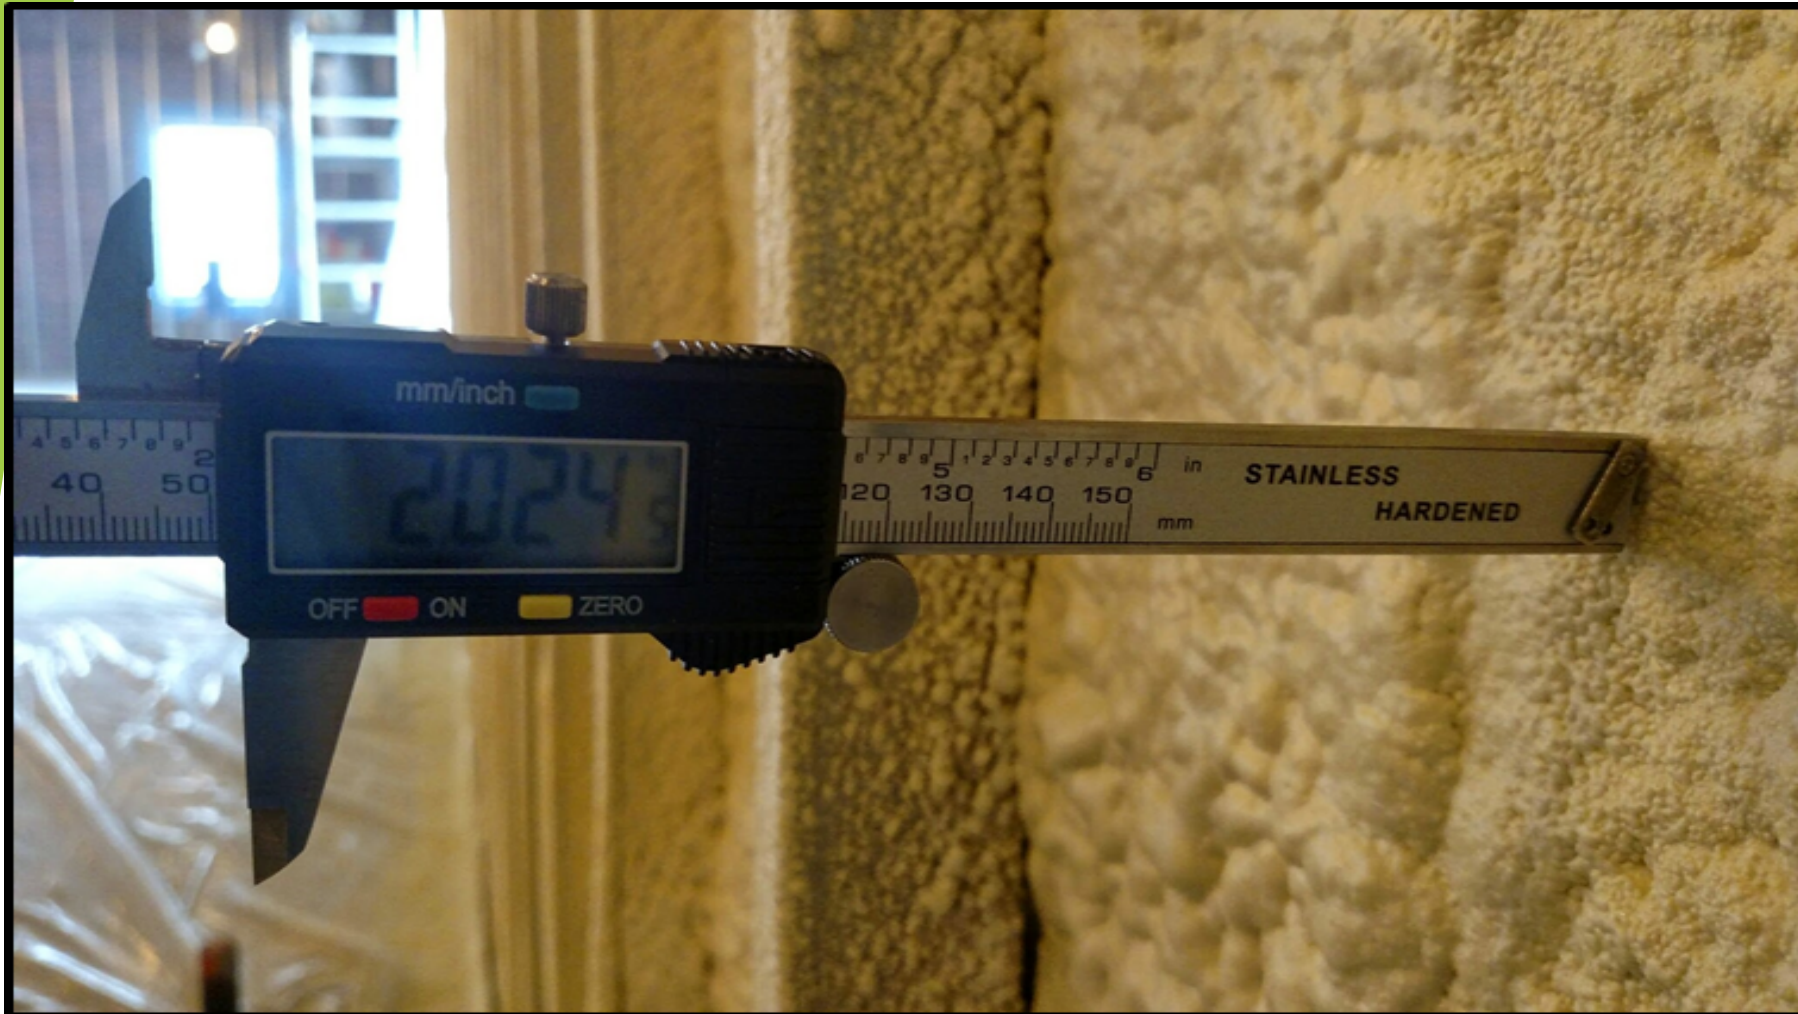
Whenever Using SPF -
Only Specify an Absolute
Minimum Thickness
