# Envelope Moisture Management for an Affordable Housing High Rise

Francis Conlin, PE, BECxP

Retrofit Conference, Charlotte, NC

# Forensic Moisture Assessment of an Existing Building Envelope

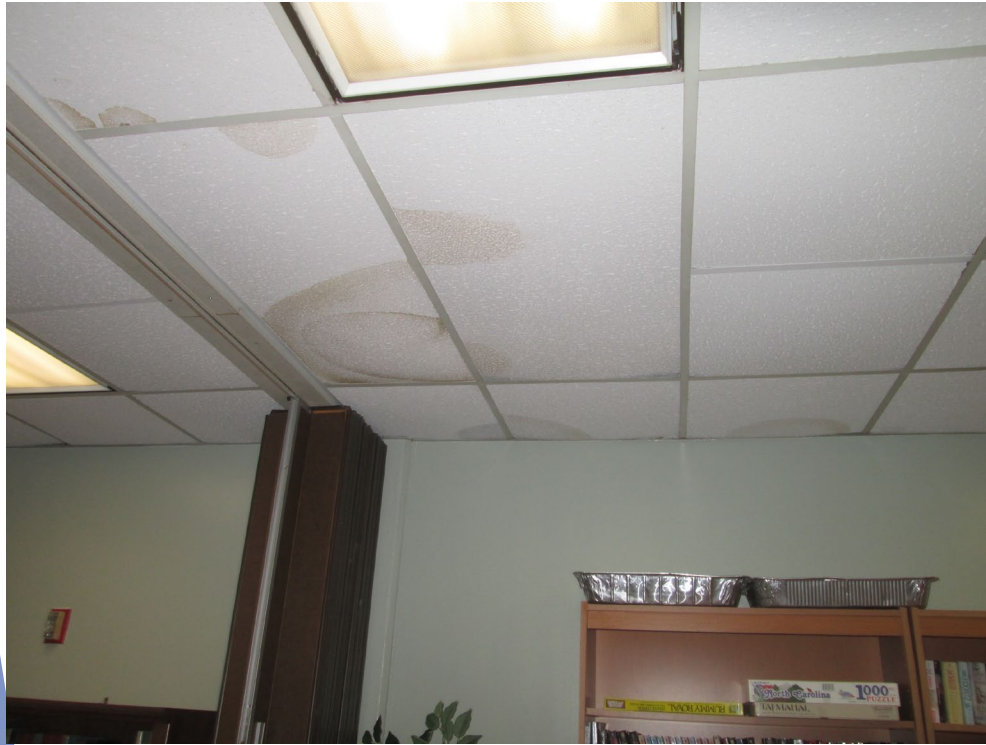
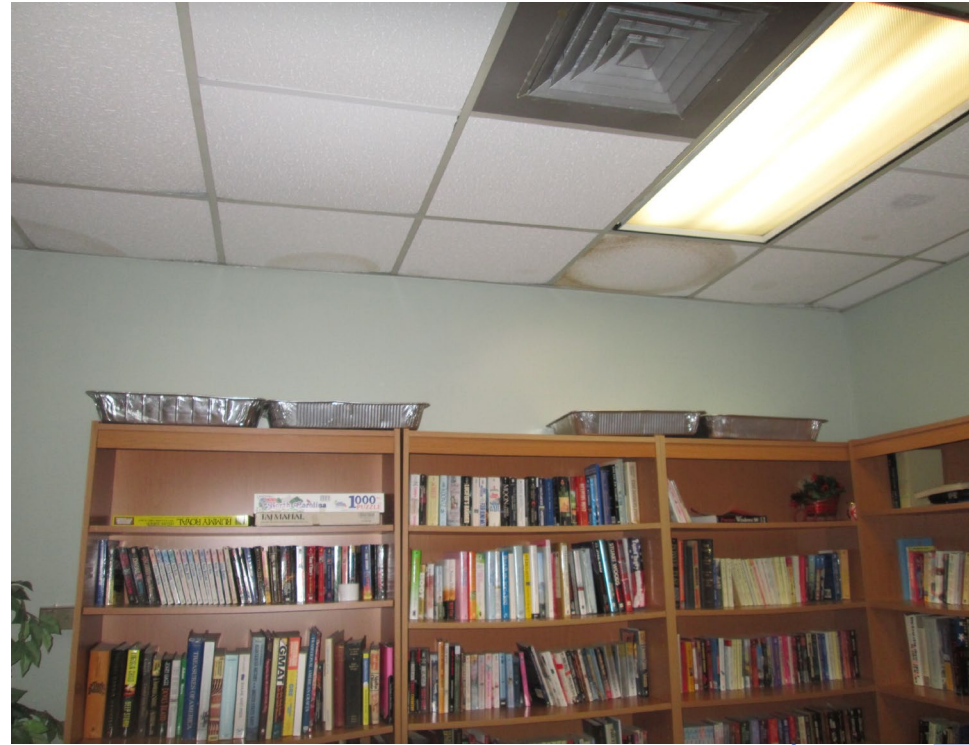
Built in 1980  
7-stories with 1 story  
Community area.

Leaks at intersection

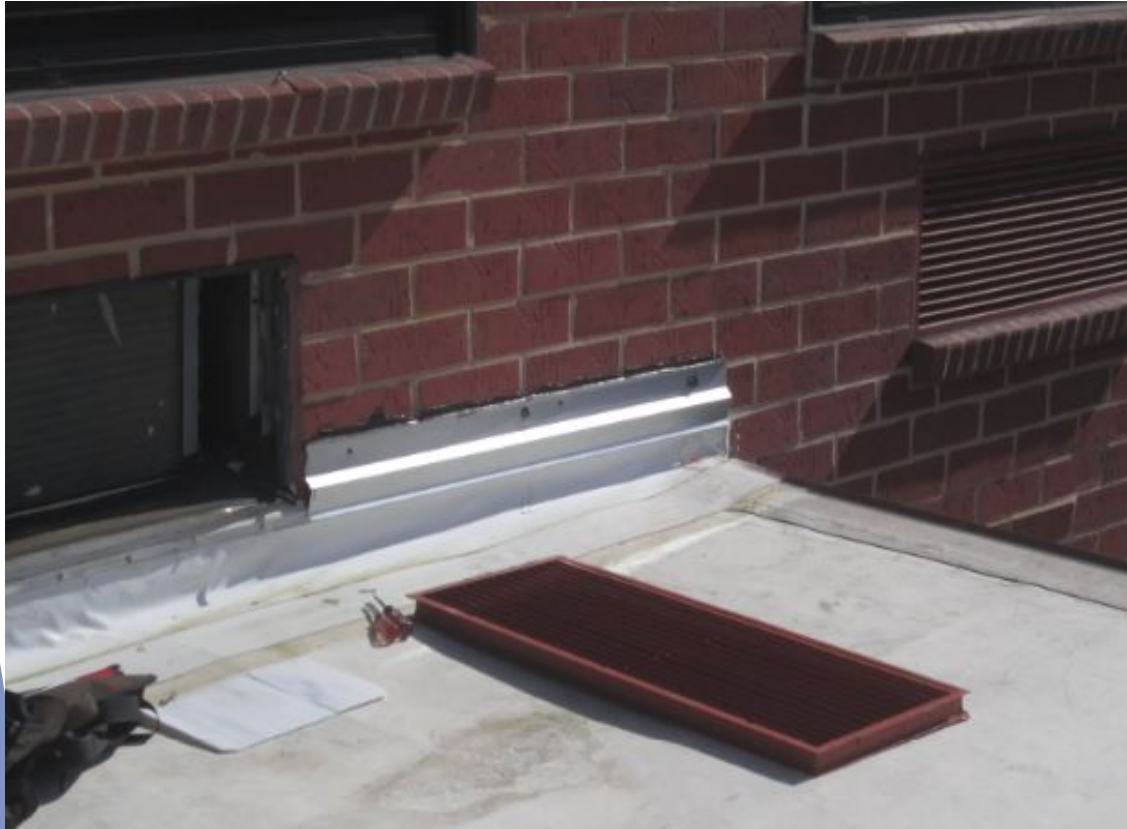
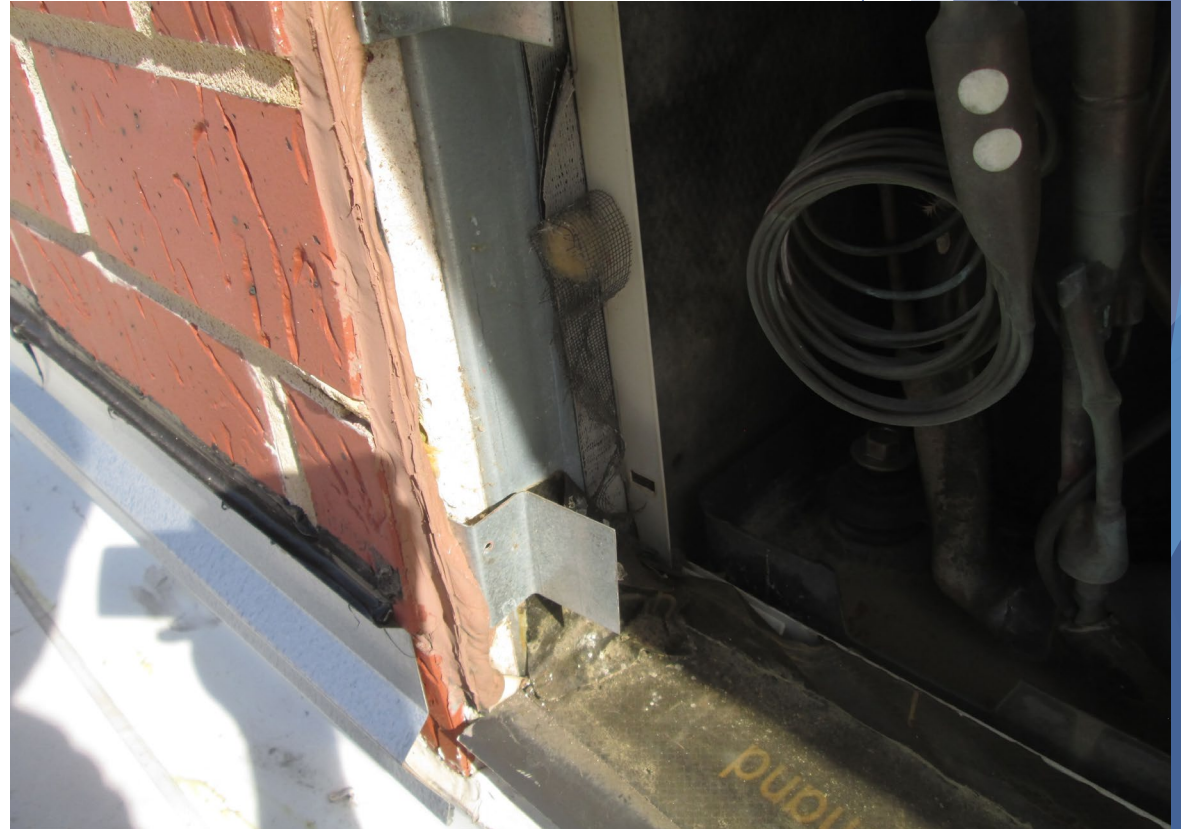
# Outside Inspection

## PTAC sleeve terminates inside wall

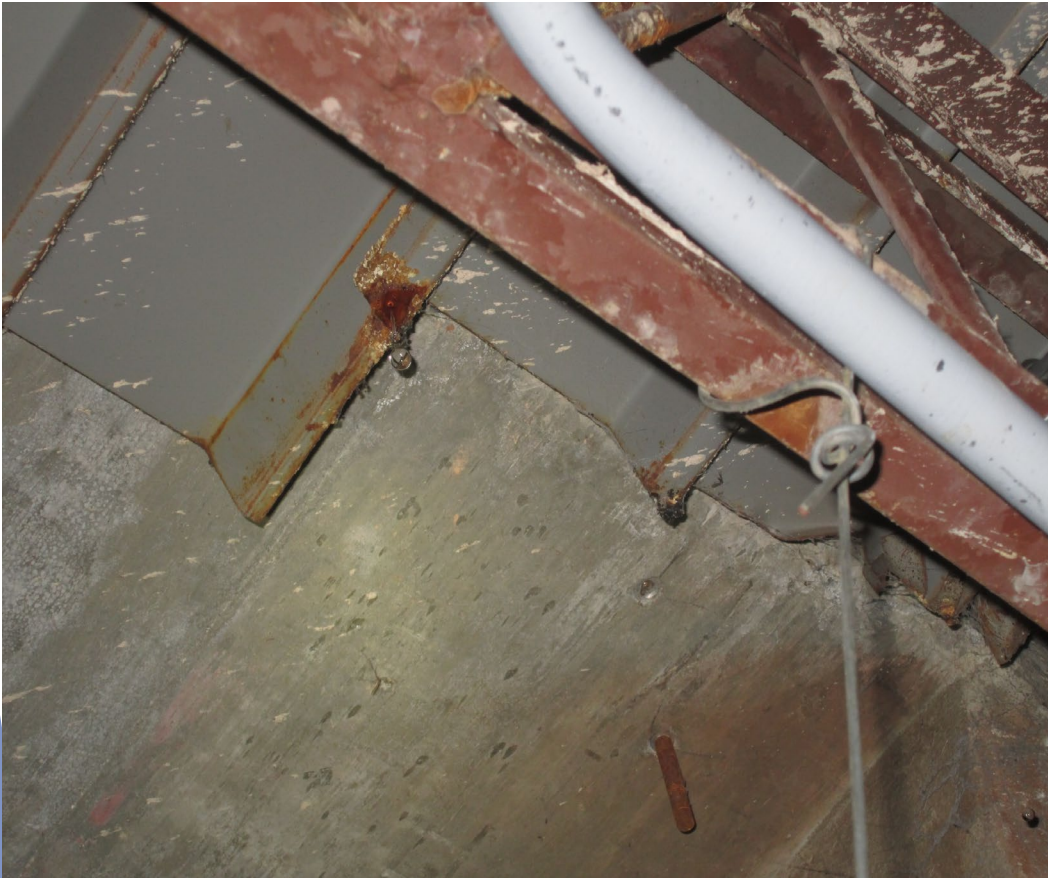
# Inside Re-Inspection

## Leaks observed when spraying PTAC

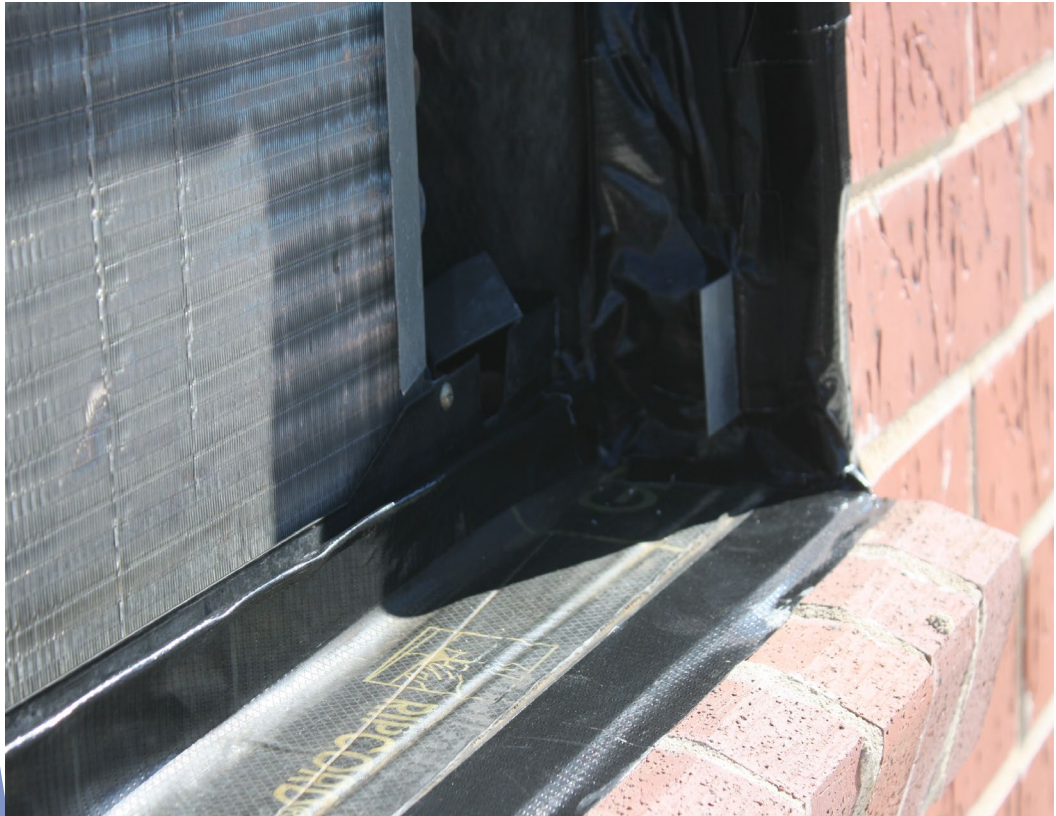
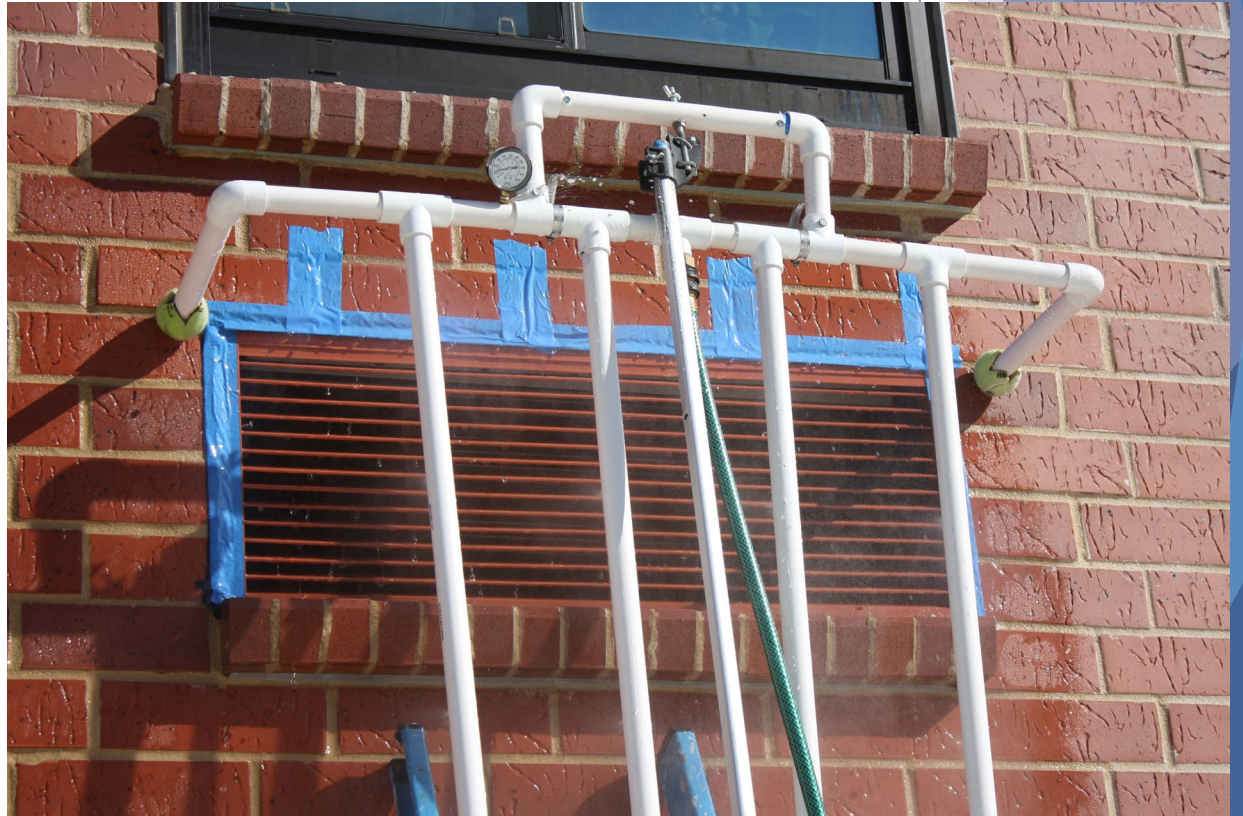
# Outside Re-Test

## Temporary seal up PTAC & exclude window

- Still leaks!

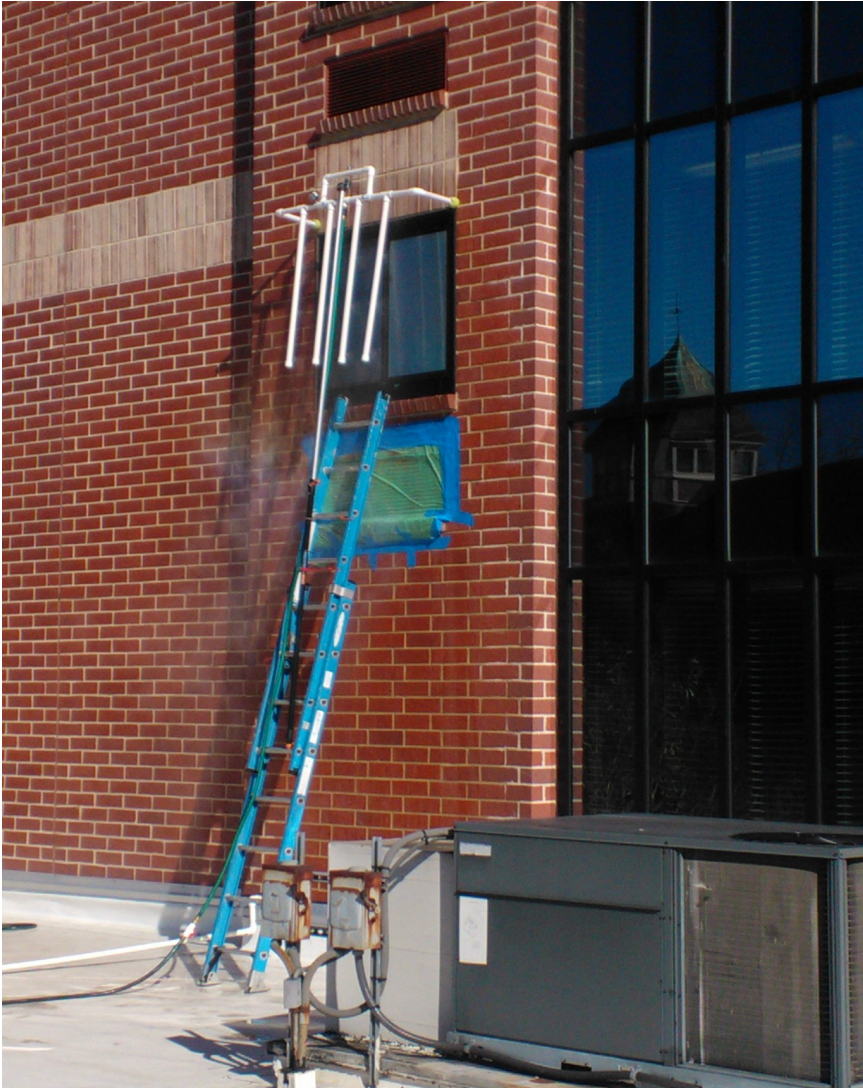
# Outside Test Again – Window Window-Only Leaks

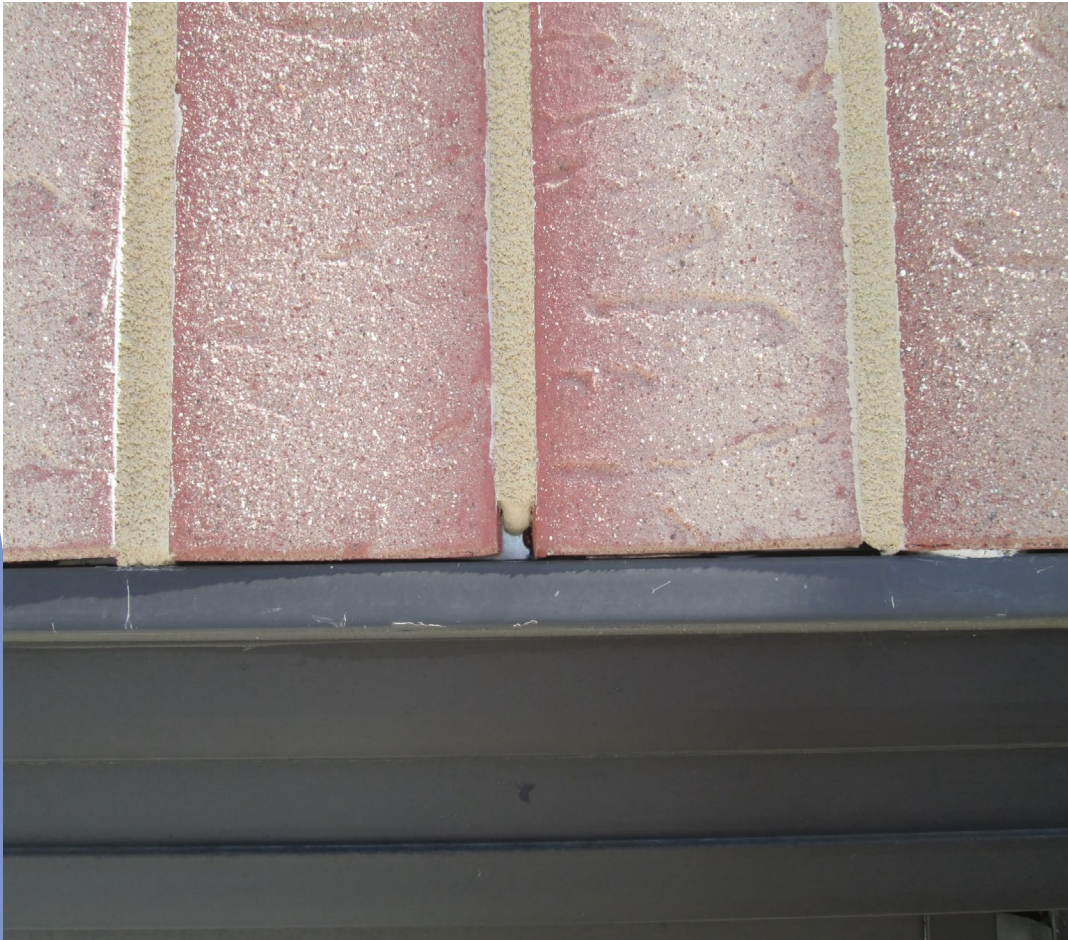
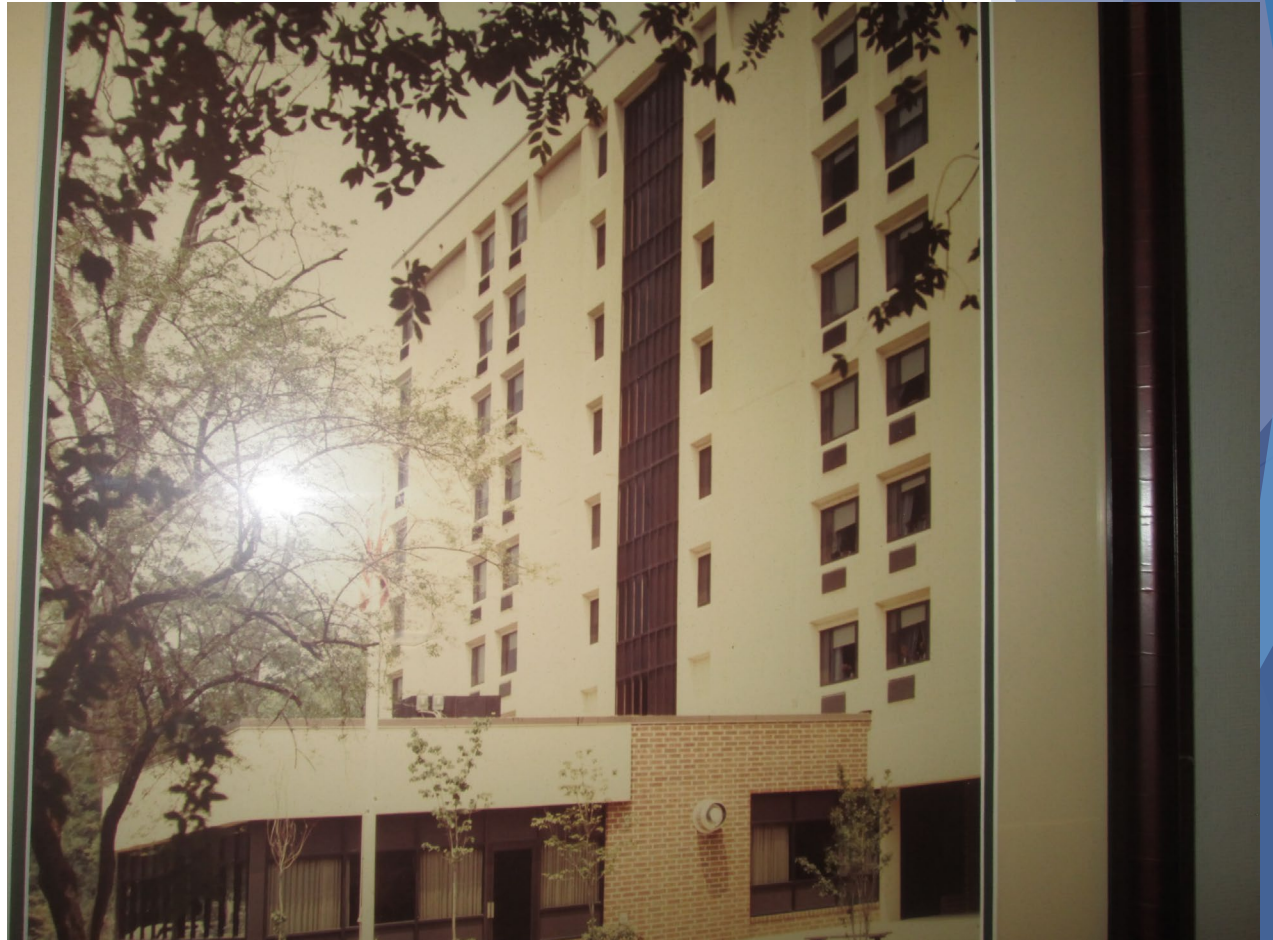
Additional Information:  
Thin brick cladding? Original stucco cladding?

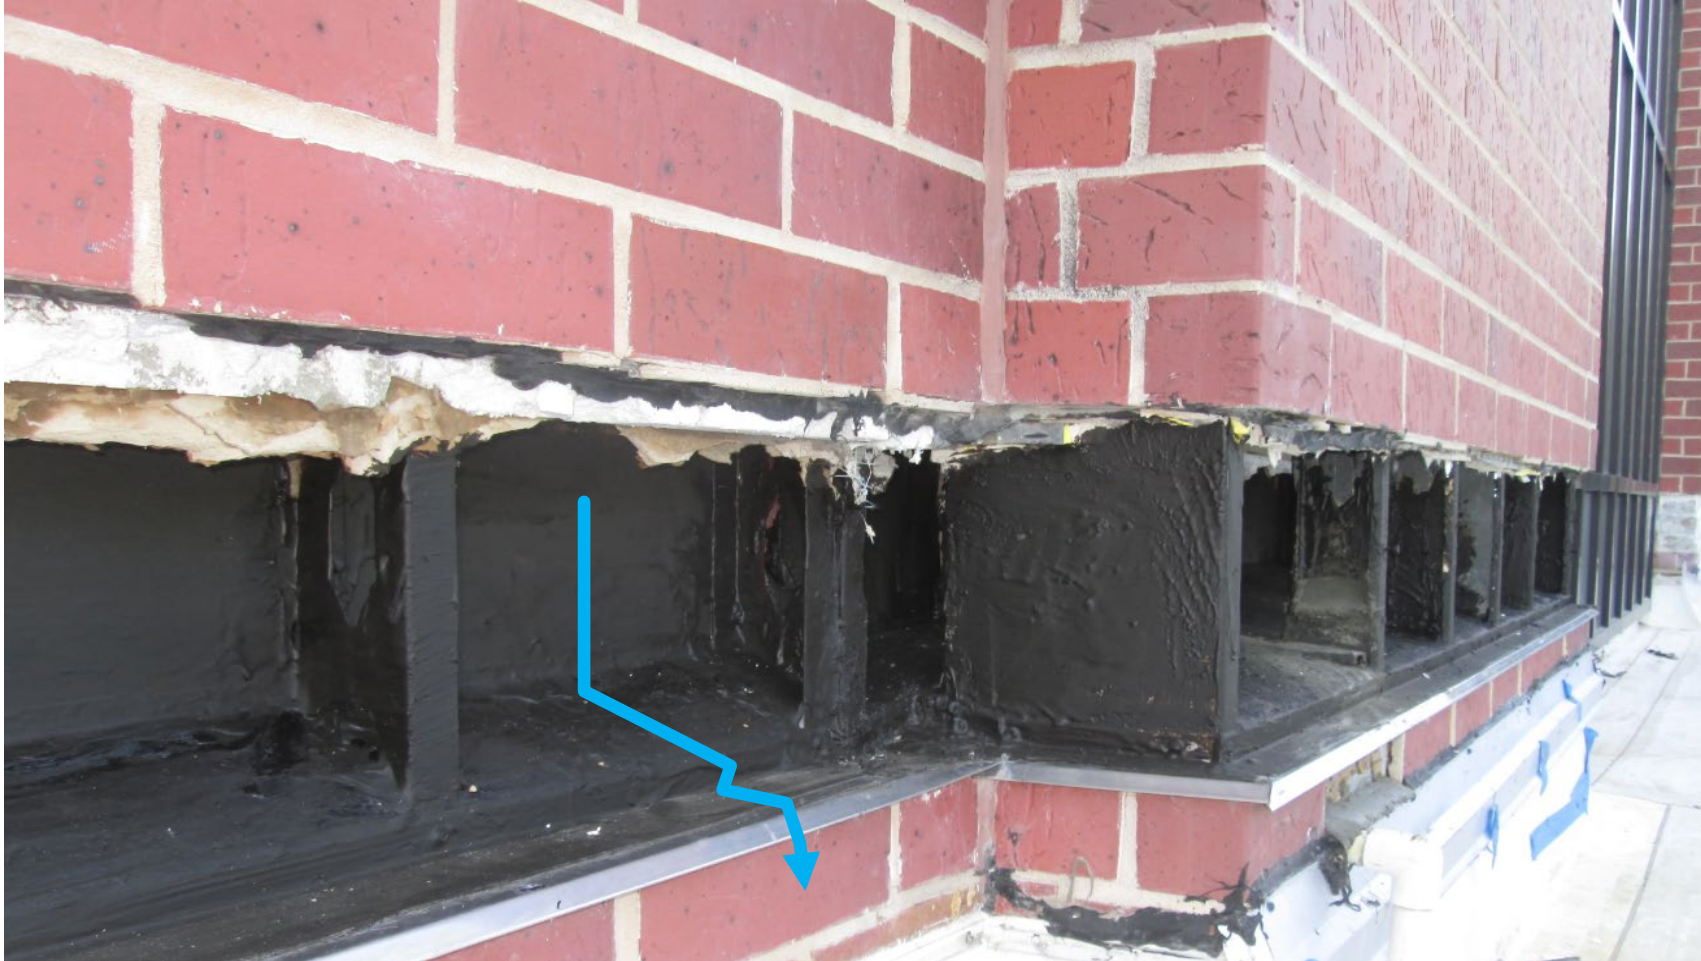
## Manage moisture with a drainage shelf

# Repair Requires Removal and Recladding

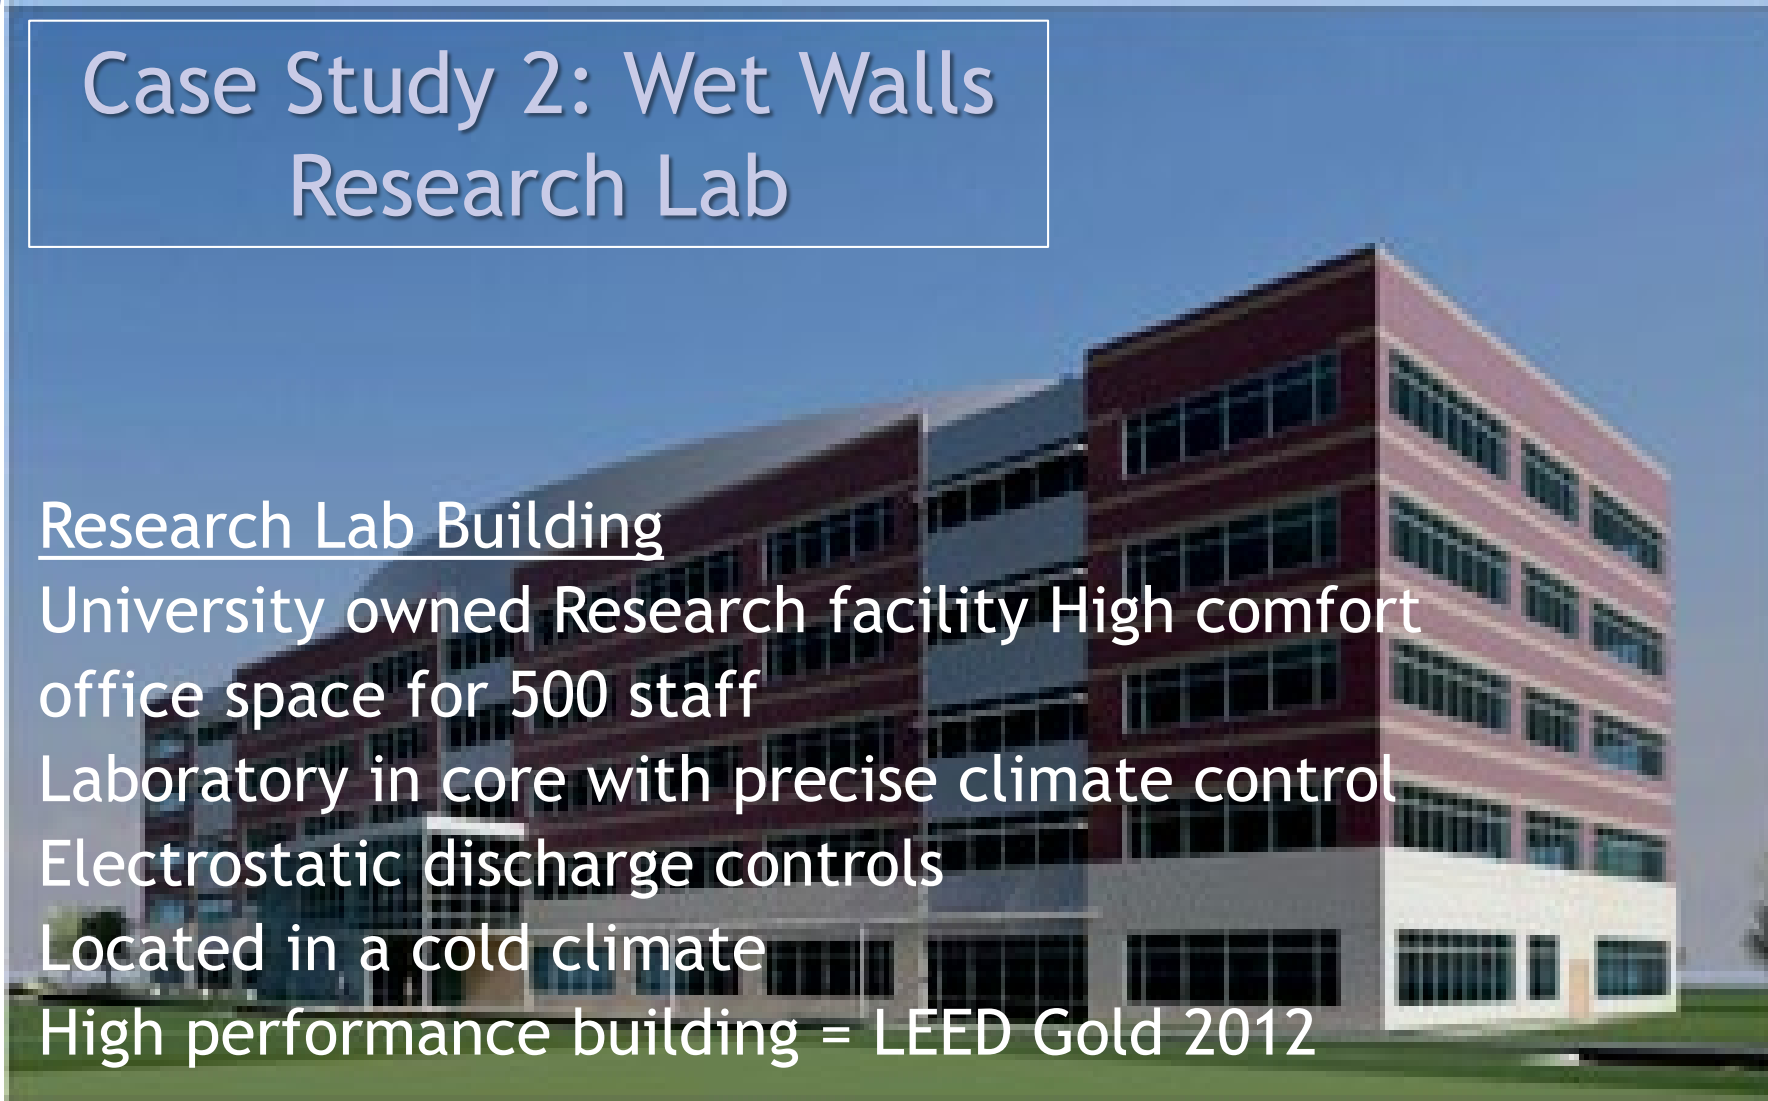
**Precast Concrete on a metal frame.**  
**Note the sequence of construction.**  
**I-Beams go up first, Precast gets hung**  
**off of the I Beams**  
**Then the rest of the wall assembly is**  
**built around that.**

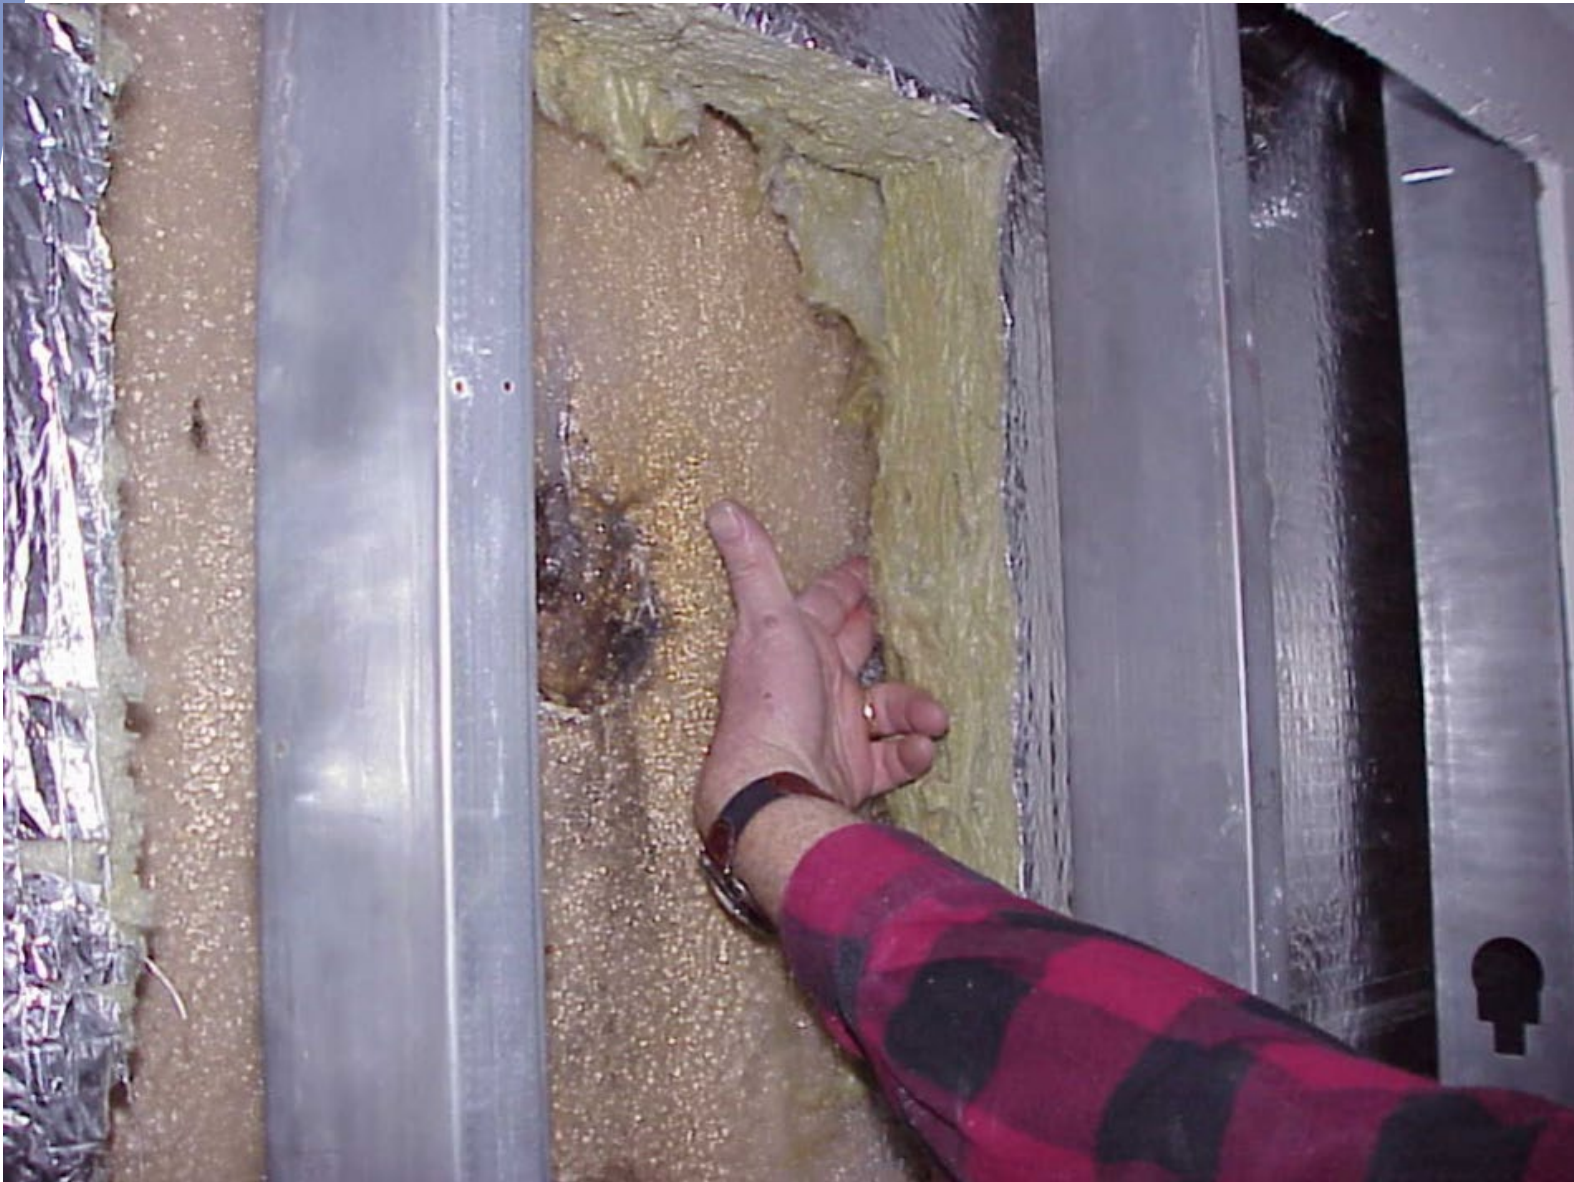
On really cold days moisture Froze on the precast concrete walls and built up for several days until a warm spell melted it all at once.

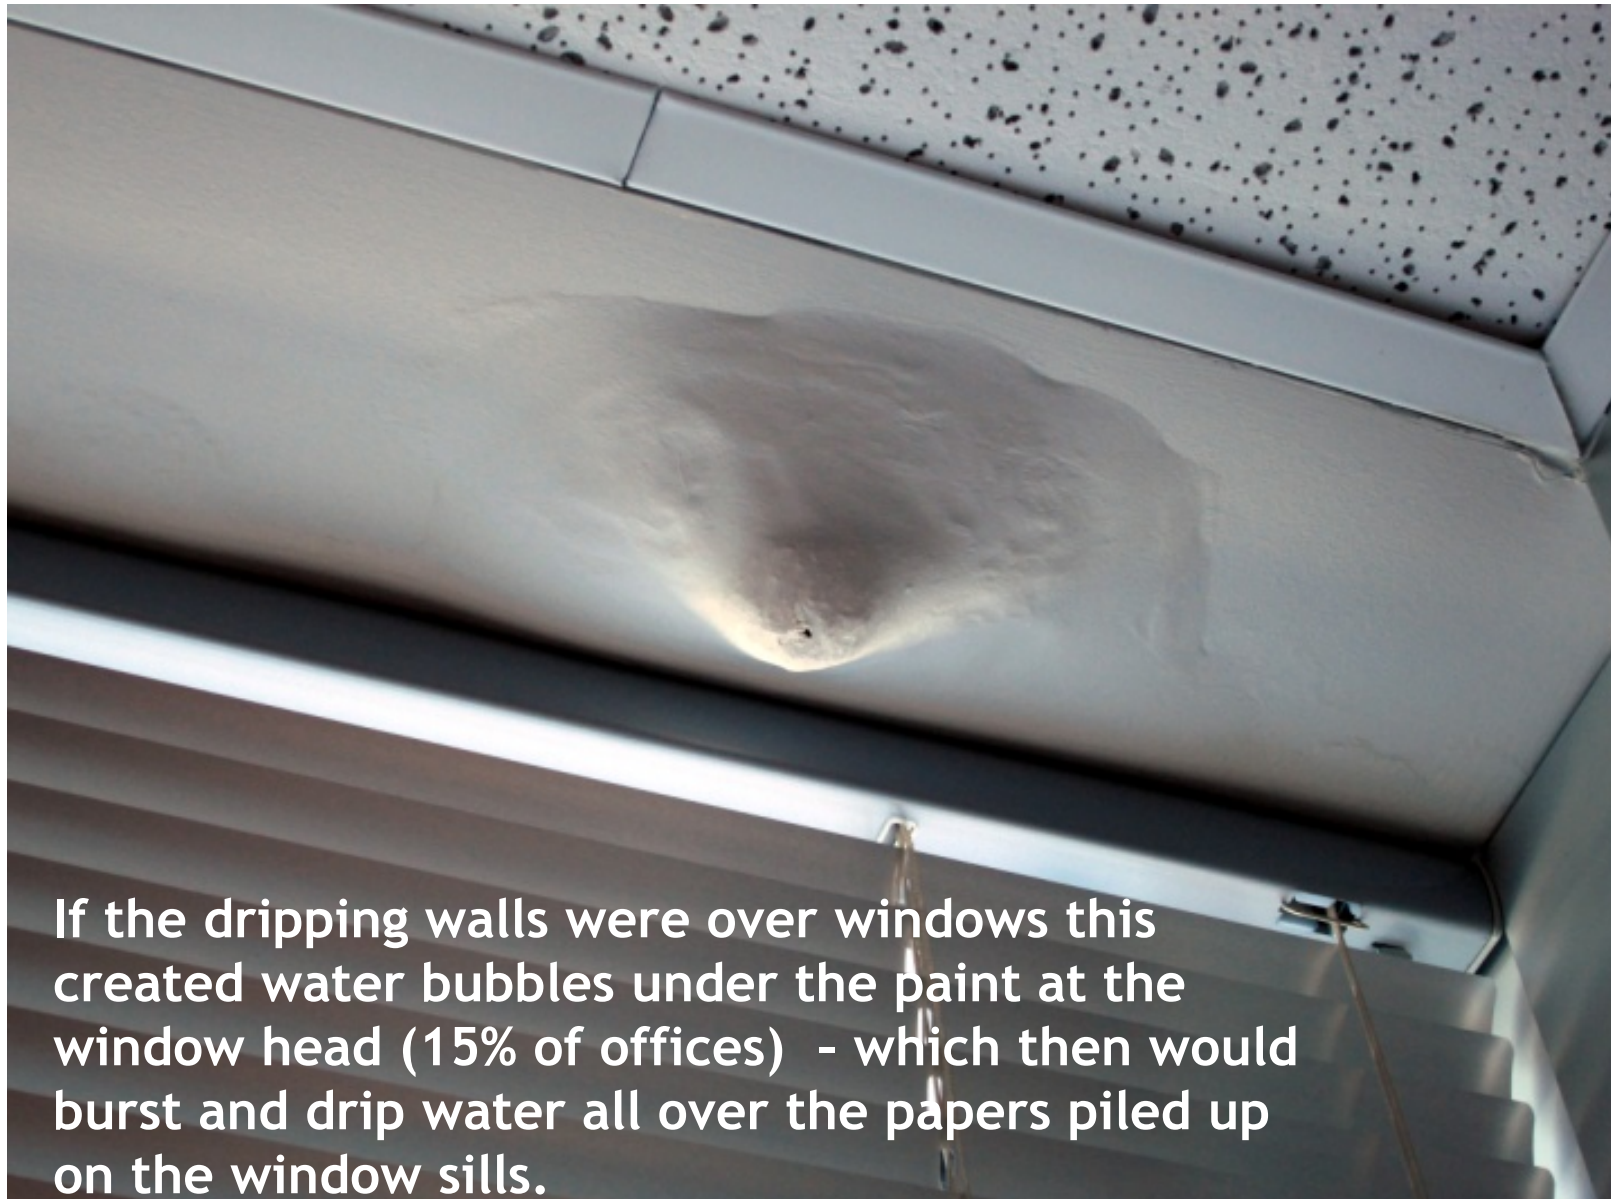
On really cold days moisture Froze on the precast concrete walls and built up for several days until a warm spell melted it all at once.

If the dripping walls were over windows this created water bubbles under the paint at the window head (15% of offices) - which then would burst and drip water all over the papers piled up on the window sills.

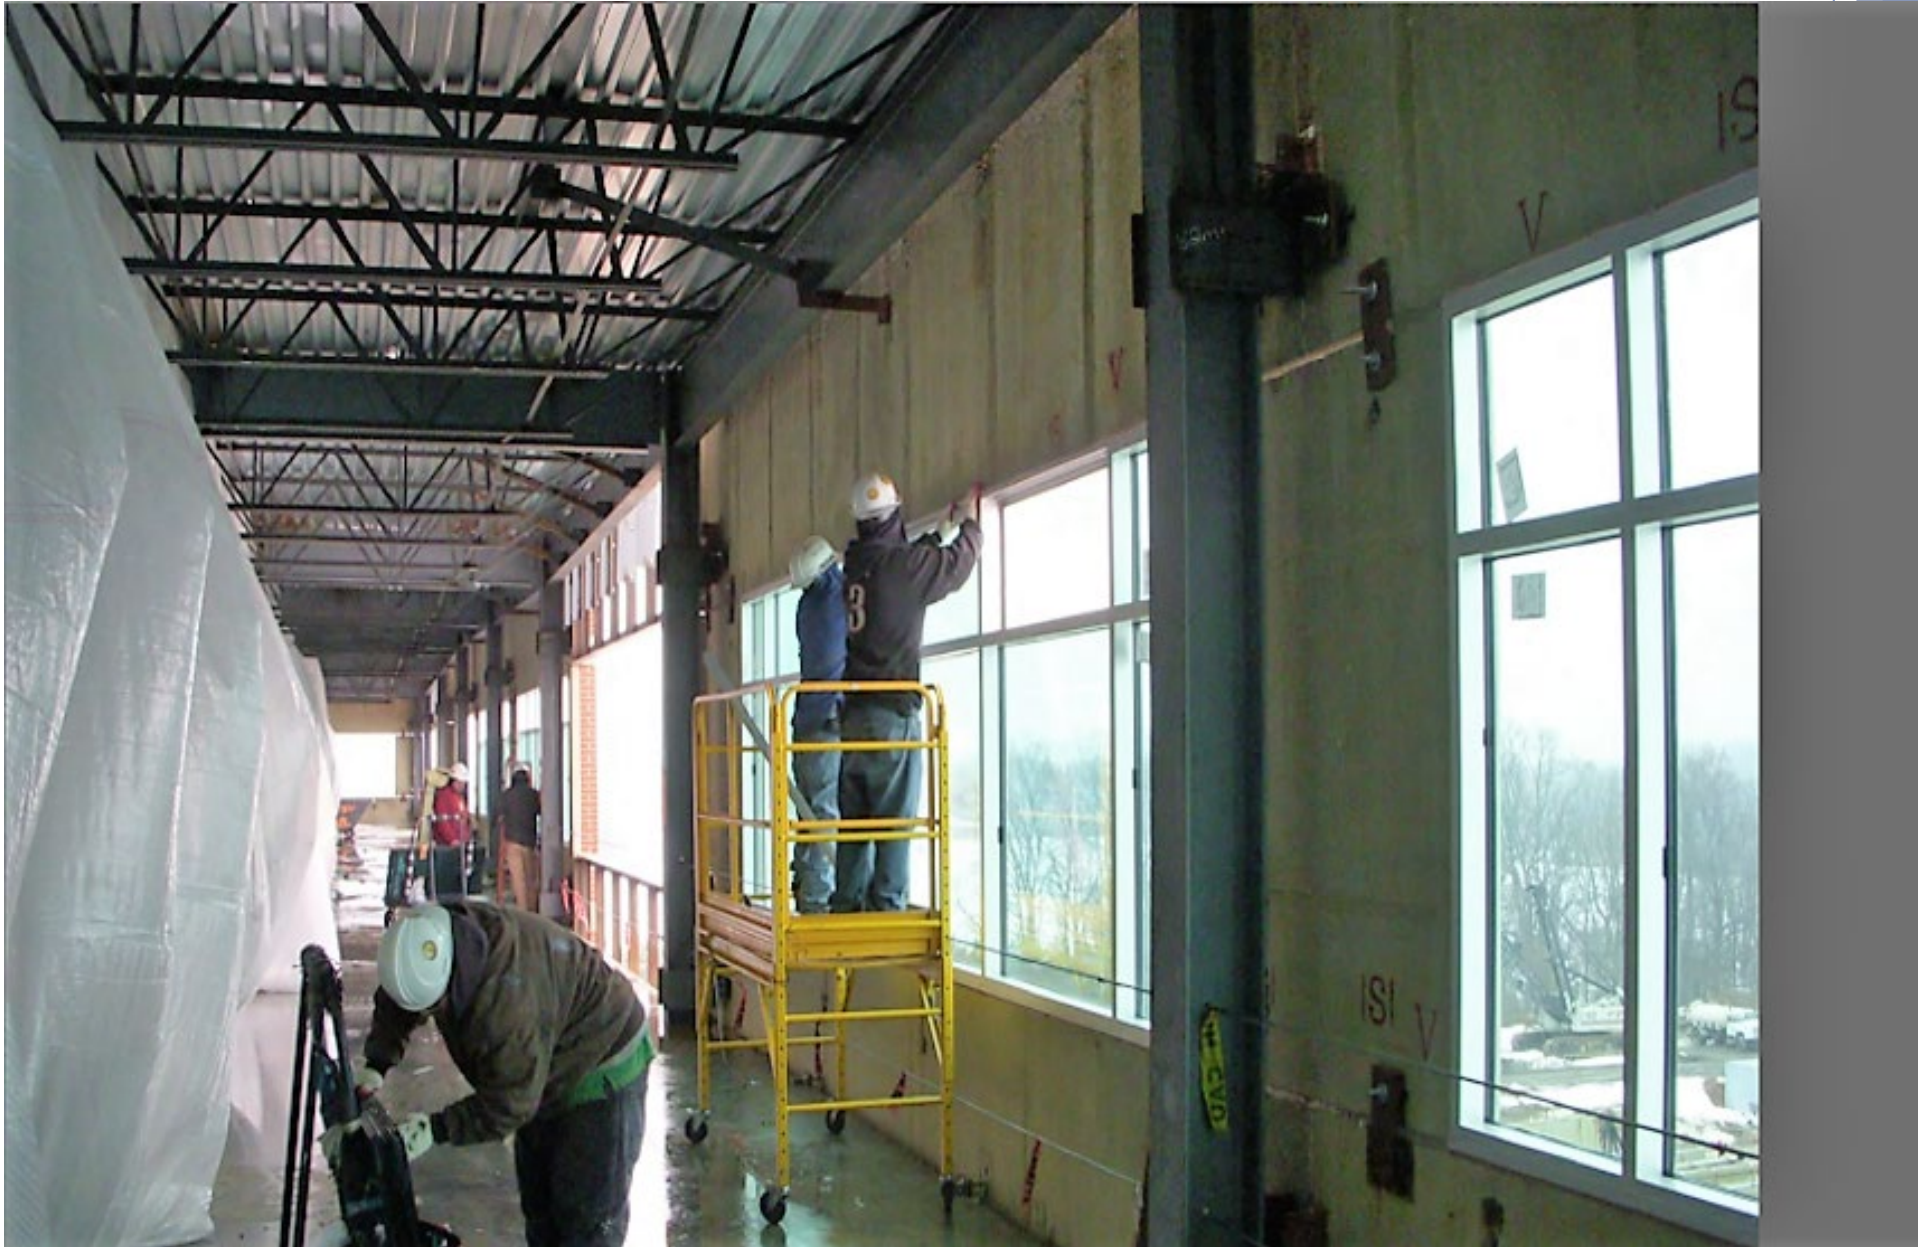
The second design is very difficult to build. How do you tape foil faced insulation behind and around the I-Beams to make a continuous vapor or air barrier?

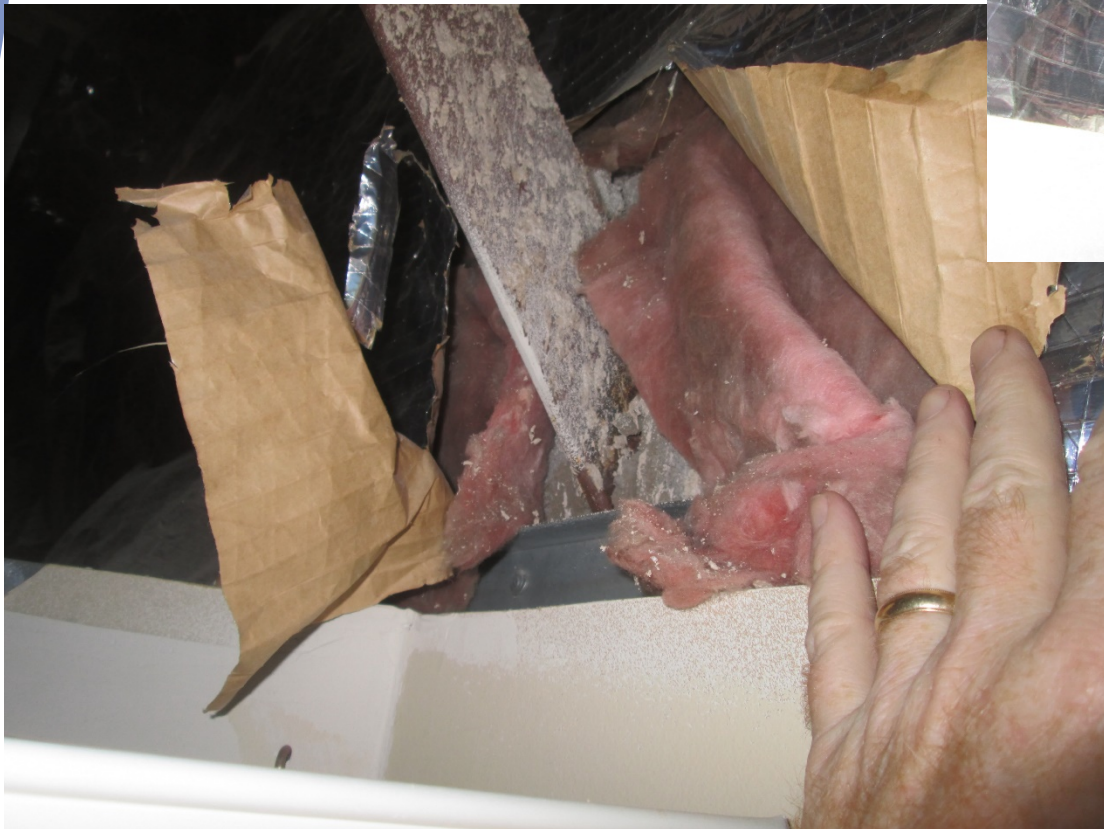
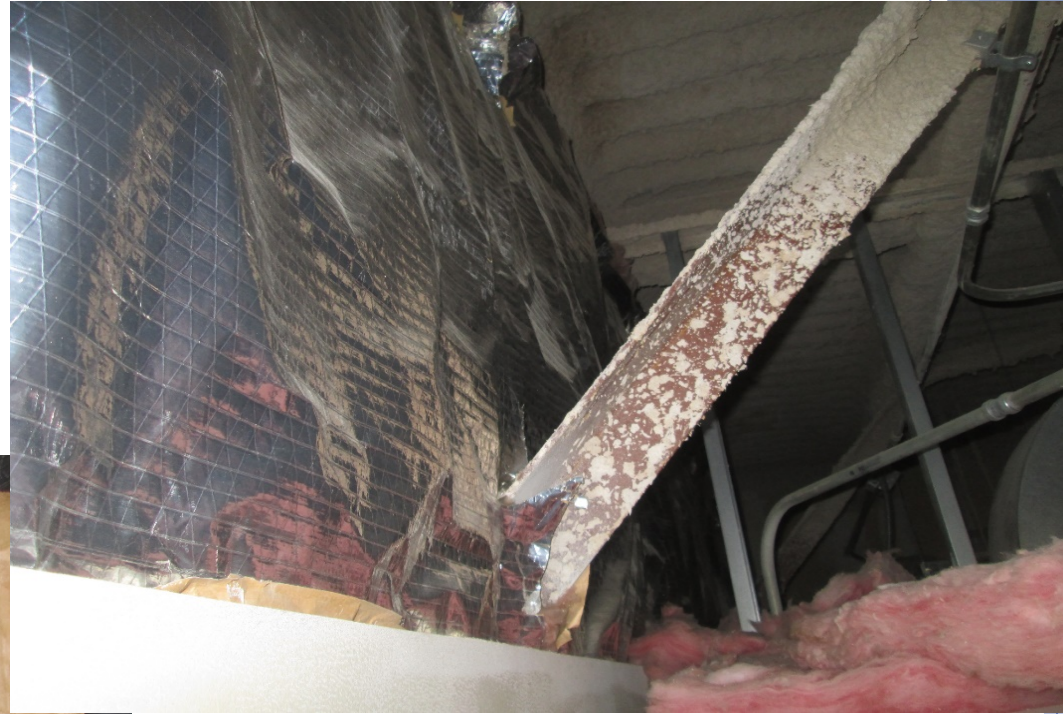
The second design is very difficult to build. How do you tape foil faced insulation behind and around the I-Beams to make a continuous vapor or air barrier?

Usually what happens:

IR photos show heat signatures along the hard-to-reach I-beams areas illustrating where air leakage into the wall assembly is occurring.

**Reinsulate and monitor for the repair mock-up**
